Inspection Report

Property Address:
1234 Money Well Spent Ln.
Charlotte NC

Americas Choice Inspections
PO Box 49271
Charlotte, NC 28277

Date: 10/5/2013	Time: 02:00 PM	Report ID:
Property: 1234 Money Well Spent Ln. Charlotte NC	Customer: Mr. Rent to Buy	Real Estate Professional:

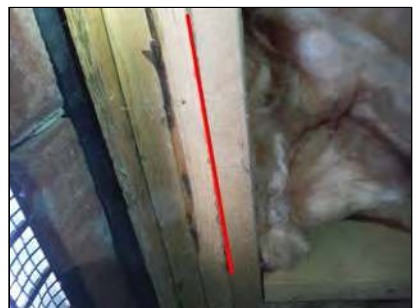
9

9. Several termite tubes noted at the front door area, the left side of the porch (as you face the street) and at the first pier to the left of the porch (as you face the street) There were also tubes noted front band pieces from the porch to the formal dining pier previously noted.

(1) Due to the following areas, but not limited too, contact a licensed termite company for treatment and a licensed contractor to determine the extent of any damages and make all repairs as needed:

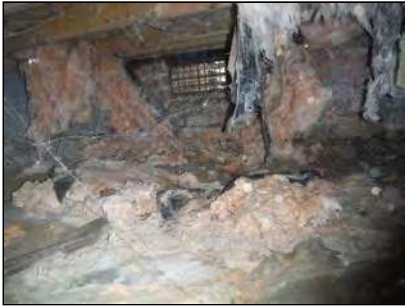
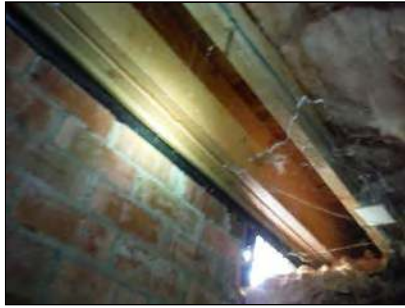
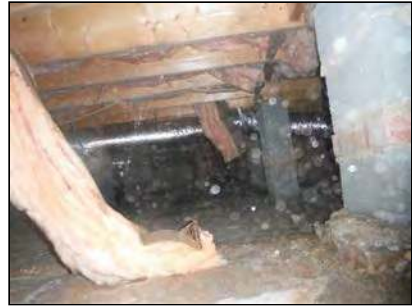
(2) There were various areas of fallen or missing insulation. The right, rear corner appear to possibly have been from a pest. Contact a licensed contractor for review and make repairs as needed.

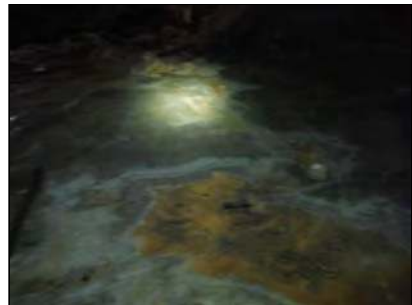
There are signs of water entry under the home front the right side of the house over to the left side of the home. The source of the water needs to be determined and correction made to stop the issue. (See exterior grading as possible source) Contact a licensed crawl space ceiling company to review and make repairs as needed.

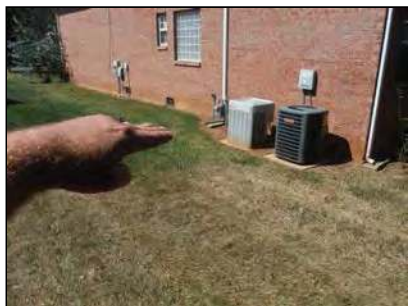
Right side

The grade at foundation needs correction at the right. The grade slopes toward the home and needs correction or properly drainage installed to direct water away from the foundation. The tenant also noted that large amounts of water travel across the rear of the home and stand at the left, rear yard. It was noted that the neighbor has installed a pool and changed the original grading of the lot. There is a large drain at in that yard at the right, rear corner. This may be the cause of the pooling water. Corrections are needed so that the lot will drain properly.

It was also noted that water is pooling under the rear sunroom as noted by the stains on the wall and post. Have a licensed contractor or professional landscaper review and make the necessary corrections as needed. (see crawl space notes also)

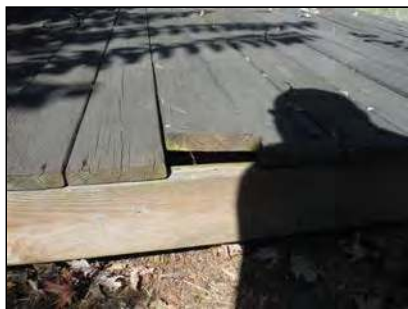
1

1. Various deck boards are cupping and/or loose. Protruding screw heads are also a safety hazard.
2. The staircase treads show signs of moisture damage and needed to be re-sealed.
3. The staircase stringers are not fully supported at the deck ledger. This can allow the stringers to split over time.

(1) The following items were noted in need of repair and/or correction at the time of inspection. It is recommended that a licensed contractor review the entire deck and make any additional repairs as needed:

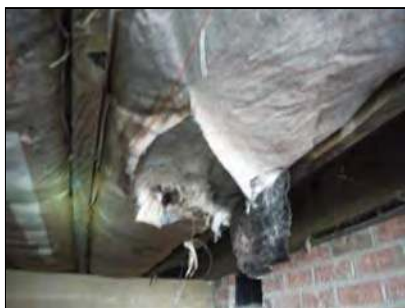
(2) Below the sunroom - the insulation is installed backwards. This locks moisture inside the room not out of it. There were also signs of a pest living in an area of the insulation near the left corner of the home. Contact a licensed contractor for review and make repairs as needed.

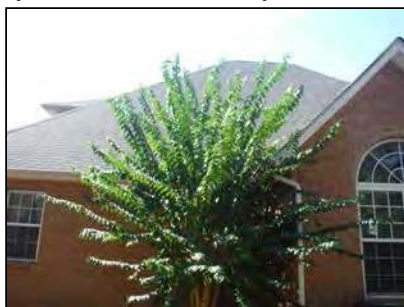
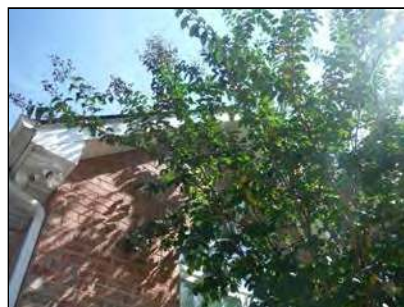
Trees are touching the roof on the home at the front, left side and the rear of the home. Tree branches can damage shingles and make easy access for pest to get onto the roof. Contact a licensed contractor for review and trim back as needed. This will be yearly maintenance once you move in.

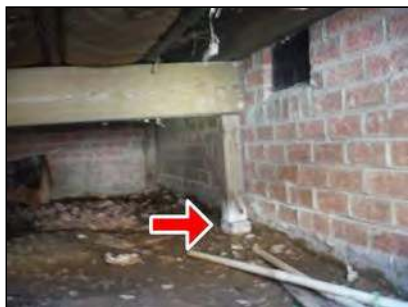
1

- post is not centered on the CMU block installed and the girder is not bolted to the current post at all connections
2. The bonus room attic tie back area nailed into the top flange of the I-joist. This can cause the flange to be disconnected as they are not designed for this force to be applied. I-joists generally require full decking to distribute loads and prevent point loading.

(1) Due to the following, but not limited too, contact a licensed engineer for further evaluation of the entire structure. Make any additional repairs as deemed necessary in their report:

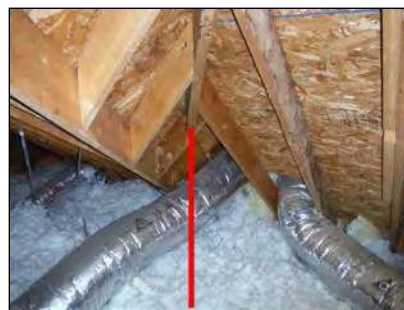
12

12. Upper attic - front of the attic across from the HVAC unit - there is a hip rafter near the valley which is not posted. This can allow the rafter to sag/fail.

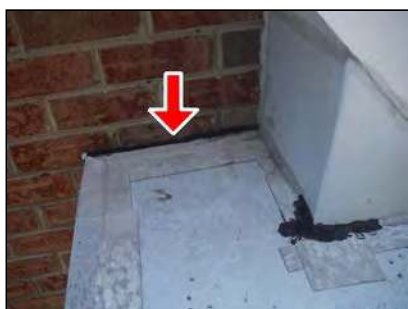
No flashing to brickwork

1. The rear addition roof is not flashed to the house in a typical fashion. A tar tape product is in use and there was no flashing at the left corner (as you face the street) There are signs of leaks noted inside the sunroom above the entry door (and the tenant said it does leak), at the rear soffit area and at the left side soffit area (as you face the street)
2. The rear addition roof has gaps at the seams running from front to rear. This can allow water penetration and needs to be corrected.
3. Garage - above the rear side of the garage door - there was a moisture stain at this area. There were no active readings at the time of inspection, but there has been no rain lately. Inside the attic above this area the sub-roof is stained at the house corner. There is also a "hard corner" above this area where the water from the

upper roof gutter is running down the roof to this corner. Ask the seller if a previous repair was made. If not then further evaluation and repairs are needed.

(2) The following items were noted in need of repair and/or replacement on the roof. Contact a licensed roofing contractor for further evaluation and make any additional repairs as needed:

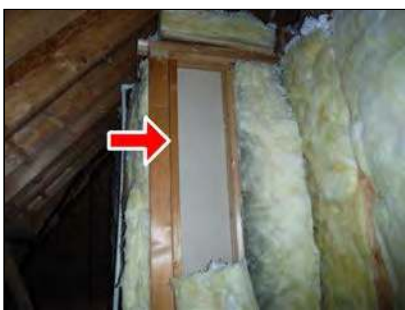
(2) Upper walk-in attic - to your left past the first corner - there was a missing section of section of insulation which needs to be installed to prevent heat loss.

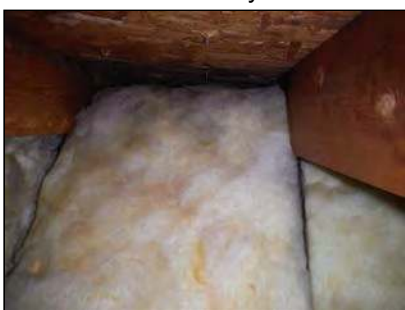
(3) Bonus room attic - there did not appear to be any baffles installed between the roof and the installed ceiling insulation. This prevents air from traveling from the soffit to the ridge. Correction are needed so that the roof will vent properly. Contact a licensed contractor for review and make any additional repairs as needed.

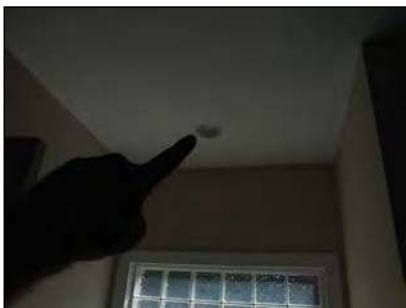
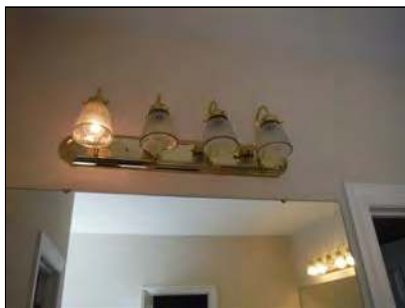
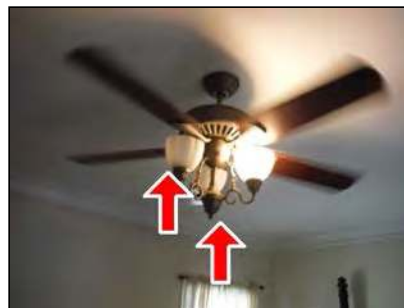
(1) Multiple lights did not function when tested. Replace the bulb and re-test to be sure it functions and is not an electrical issue. Contact a licensed electrician if replacing the bulb does not correct the issue:

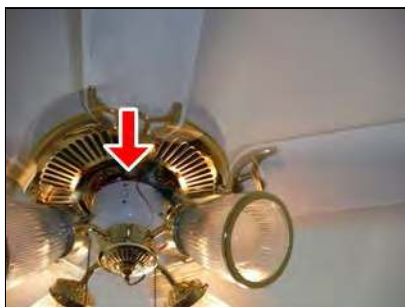
(2) Bonus room - there was a balloon string caught up in the fan which needed to be removed to prevent the motor from being damaged.

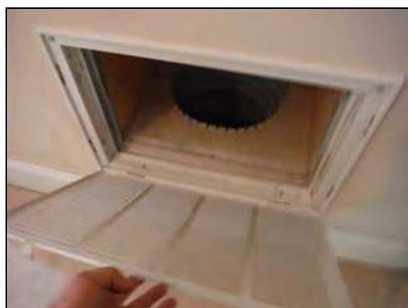
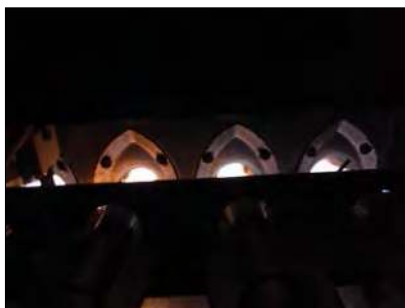
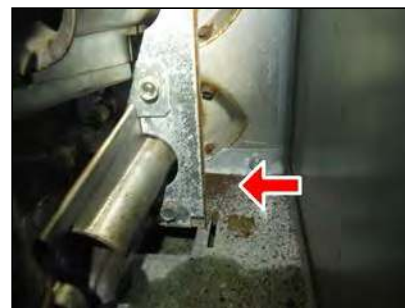
1. The air filter(s) were missing at the time of inspection, replacements needed to prevent dirt/dust particles from entering the unit. When filters are missing it is recommended that the interior components be serviced and cleaned as this can allow dirt, lint and dander to coat and cover vital parts of the a/c system. Any other items in need of repair found when the HVAC contractor cleans the unit should also be addresses.
2. The rust noted in the burner area and dancing/changing of the flame color from blue to red/orange when the house fan kicks on is an indication of a possible cracked heat exchanger. Contact a licensed HVAC contractor for a full, invasive inspection of the system. Repair/replace as needed.
3. There was rust noted at the left side of the exterior of the unit below the elbow of the vent pipe
4. Air gaps noted at the plenum need to be sealed.

Due to the following, but not limited to, it is recommended that a licensed HVAC contractor further evaluate the entire system and make any additional repairs needed:

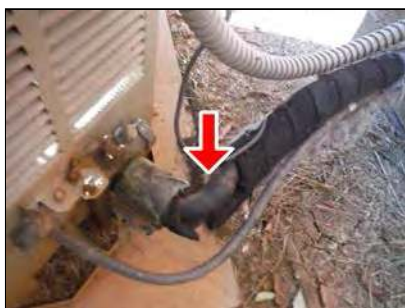
More insulation is needed on the exterior Freon line where it is worn, torn or missing

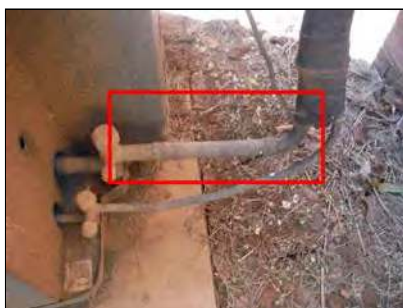
More insulation is needed on the exterior Freon line where it is worn, torn or missing

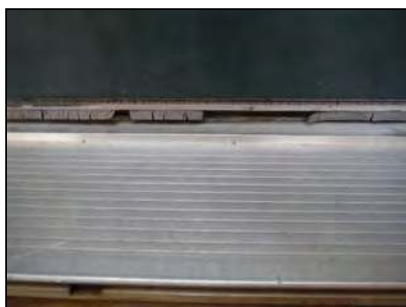
1

1. The bottom weather stripping was torn/damaged and needed to be replaced to prevent water penetration.
2. The bottom of the door is rusting. Determine cause and make repairs/replace as needed.

The following issues were noted in the need of repair and or adjustment at the front door. Contact a licensed contractor for review and make and additional repairs as needed:

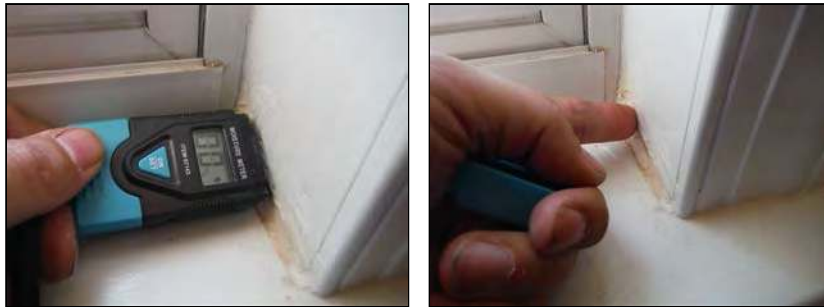
(2) Master bathroom toilet closet window - there were water stains at the lower, right corner of the window. This area was also soft to the touch. There were no moisture readings found at the time of inspection. Ask the seller if there was a previous repair made. If not it should be treated as an active issue and further reviewed for repair by a licensed contractor.

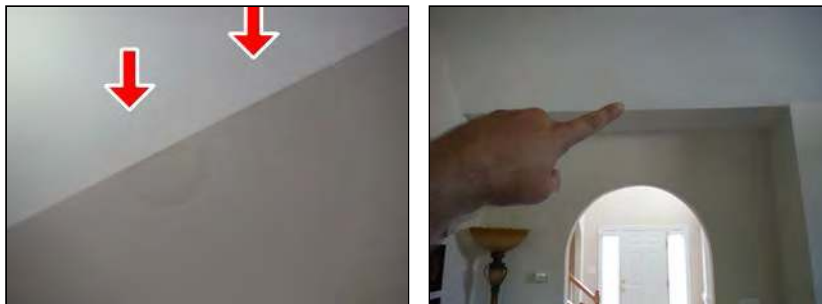
(2) Living room - above the entry way from the foyer at about the middle of the opening - there were two water stains noted in this location. Ask the seller if there was a past repair. If not, it should be treated as an active issue and further evaluated by a licensed contractor to determine the cause and make repairs as needed.

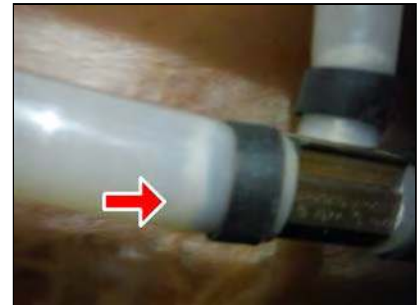
Build up inside pipe

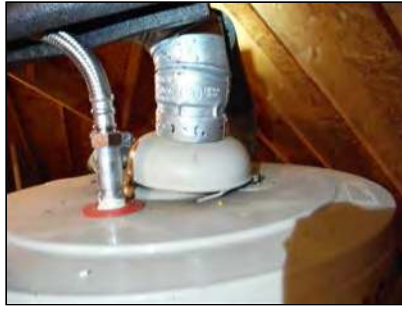
1

1. The flue is crushed down on top of the top of the water heater. It appears to be too long. Corrections are needed so there is adequate dilution air to push the flue gases up and out of the flue.
2. There are scorch marks on the front of the service door area. This is a sign of flame roll out in need of correction.

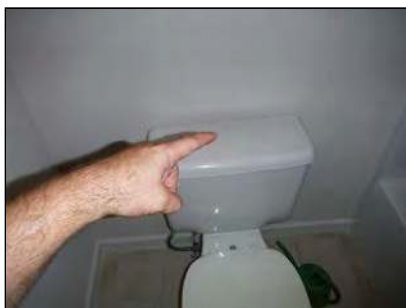
1. There are gaps around the tiles at the base of the toilet and the toilet itself. This can allow water to travel under the toilet as people get in and out of the shower or during mopping. The gap needs to be sealed.
2. The toilet continues to run after it has been flushed. The inlet valve float is not adjusted at a proper height and needs adjustment/replacement so that toilet will stop running when not in use.

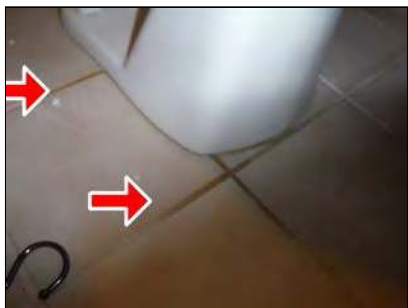
1

1. Staining or discoloration was noted on the floor around the toilet. This is indication that the toilet is leaking or has leaked in the past. Ask the sellers the history of the toilet and leaks that may have occurred. If the seller is unaware of the staining or discoloration then the toilet should be considered of having an active leak. Have a licensed plumbing contractor further evaluate the toilet and have a licensed general contractor further evaluate the flooring to ensure that there is not additional hidden or concealed damage. (See ceiling notes as possible source)
2. The toilet did not flush properly at the time of inspection. The handle must be held down to get a full flush.

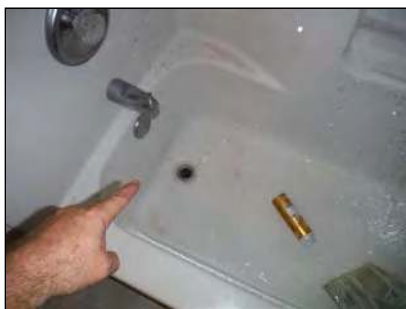
1

1. The drain stopper was missing at the time of inspection. Replacement is needed so the tub can hold water properly when bathing.
2. The tub spout is loose in the wall and there is a large gap when the diverter is used. Gaps of this type and size should not be caulked as the caulk will just pull away from the wall. The spout needs to be secured properly to prevent water penetration behind the wall.

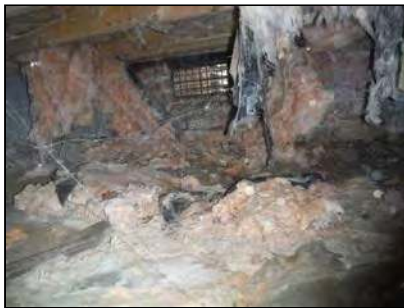
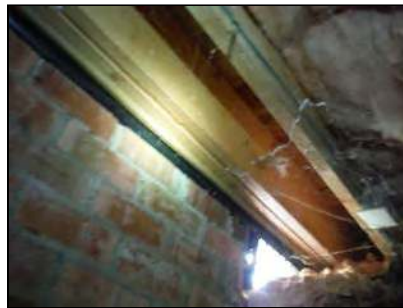
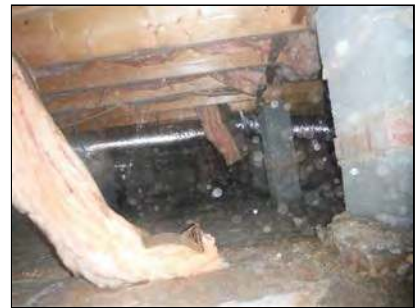
(2) There were various areas of fallen or missing insulation. The right, rear corner appear to possibly have been from a pest. Contact a licensed contractor for review and make repairs as needed.

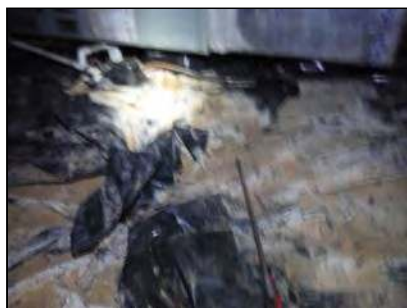
There are signs of water entry under the home front the right side of the house over to the left side of the home. The source of the water needs to be determined and correction make to stop the issue. (See exterior grading as possible source) Contact a licensed crawl space ceiling company to review and make repairs as needed.

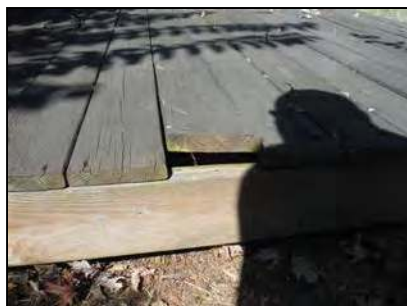
1

1. Various deck boards are cupping and/or loose. Protruding screw heads are also a safety hazard.
2. The staircase treads show signs of moisture damage and needed to be re-sealed.
3. The staircase stringers are not fully supported at the deck ledger. This can allow the stringers to split over time.

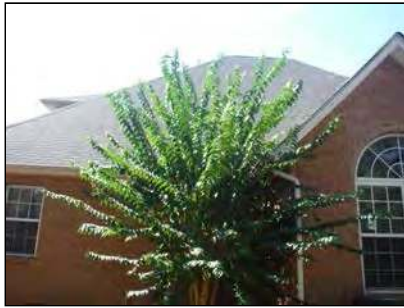
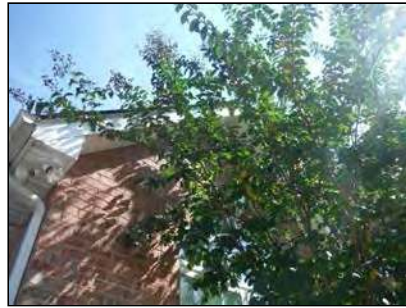
Trees are touching the roof on the home at the front, left side and the rear of the home. Tree branches can damage shingles and make easy access for pest to get onto the roof. Contact a licensed contractor for review and trim back as needed. This will be yearly maintenance once you move in.

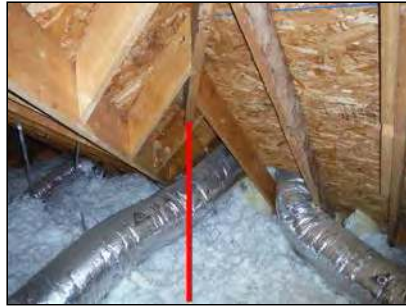
12

12. Upper attic - front of the attic across from the HVAC unit - there is a hip rafter near the valley which is not posted. This can allow the rafter to sag/fail.

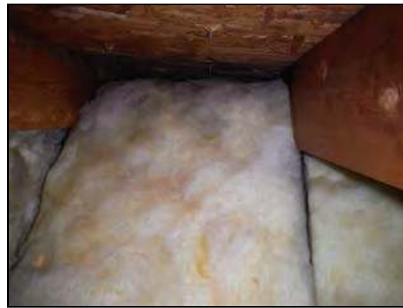
(3) Bonus room attic - there did not appear to be any baffles installed between the roof and the installed ceiling insulation. This prevents air from traveling from the soffit to the ridge. Correction are needed so that the roof will vent properly. Contact a licensed contractor for review and make any additional repairs as needed.

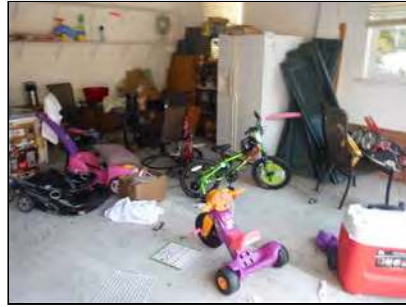
The garage walls were not fully visible due to stored items along the walls in the garage. Due to the stored items obstructing the viewing of the foundation within the garage there is no way to determine if there is termite activity. During the final walk through it is recommended that you thoroughly inspect the foundation walls for any mud tubes or you can elect to have us come back out and re-inspect the foundation walls for an additional trip fee before closing.

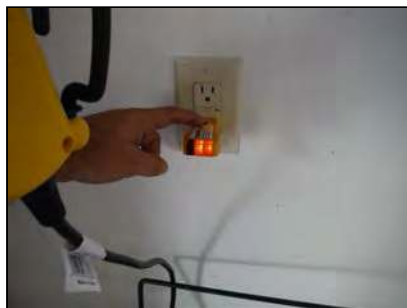
1

1. The garage outlets did not trip at the time of inspection. There was a GFCI on the rear wall, but it did not respond when tested.
2. Due to the laundry sink, all outlets within 6' should be GFCI protected and were not.
3. The sunroom outlets are installed in the floor and not floor outlets. They did not trip the installed GFCI outlet and the electrical under the sunroom was not secured adequately nor inside a conduit.

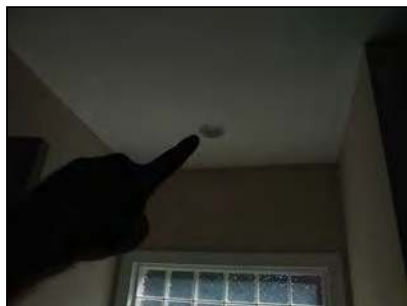
(1) Multiple lights did not function when tested. Replace the bulb and re-test to be sure it functions and is not an electrical issue. Contact a licensed electrician if replacing the bulb does not correct the issue:

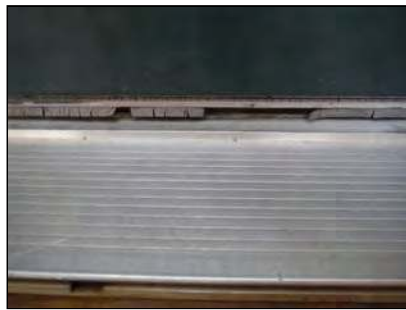
1

1. The bottom weather stripping was torn/damaged and needed to be replaced to prevent water penetration.
2. The bottom of the door is rusting. Determine cause and make repairs/replace as needed.

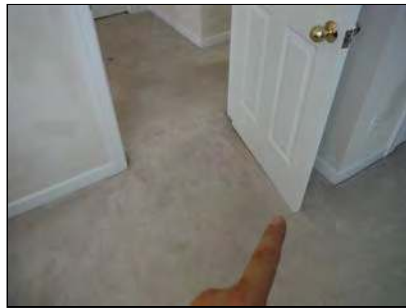
Entry door

(2) The upper, front, left bedroom entry and closet door(s) were rubbing the carpet and need to be adjusted. This causes premature wear to the carpeting, makes opening and closing the door difficult and also prevents the HVAC unit from allowing air travel between the rooms adequately. Contact a licensed contractor for review and make repairs as needed.

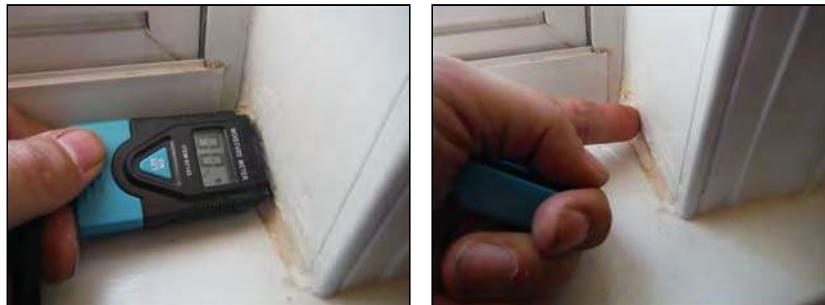
(2) Master bathroom toilet closet window - there were water stains at the lower, right corner of the window. This area was also soft to the touch. There were no moisture readings found at the time of inspection. Ask the seller if there was a previous repair made. If not it should be treated as an active issue and further reviewed for repair by a licensed contractor.

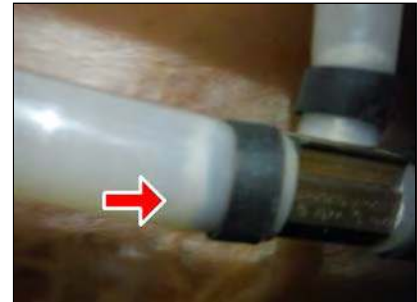
Build up inside pipe
