Inspection Report

Property Address:
1234 Test Report Street
Charlotte NC

Americas Choice Inspections
PO Box 49271
Charlotte, NC 28277

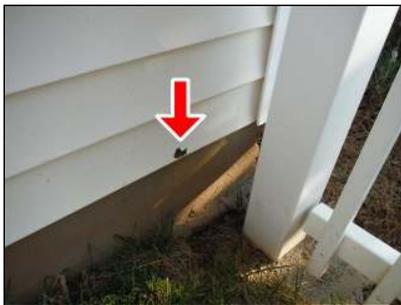
1

There were holes noted in the siding in the following locations. They need to be sealed/repaired/replaced as needed to prevent water penetration. Contact a licensed contractor for review and make any additional repairs as needed:

1. Right side of home - lower section near the rear corner of the house
2. Left side of home - lower section - several reas near the front corner of the home

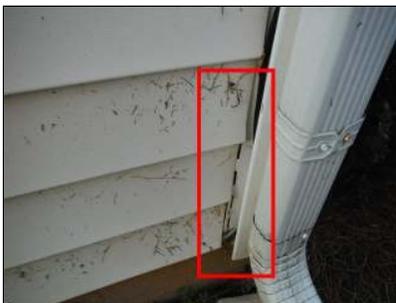
1.3 Trim Findings

Left side of home - front corner - the corner piece is loose and needs to be re-secured to properly hold the vinyl siding in place. Contact a licensed contractor for review and make any additional repairs as needed.

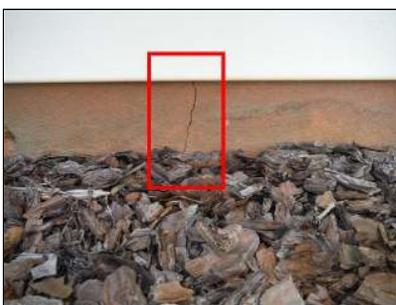
1.7 Foundation Findings

There was/were hairline crack(s) noted in the following locations. Point up and continue to monitor. No corresponding cracks were noted inside the home of these area and all windows and doors around the area were functioning as intended at the time of inspection.

1. Rear of home - right of the A/C unit (as you face the street)
2. Left wall of interior of the garage
3. Rear wall of the interior of the garage

(Please Note: - Glass monitoring kits can be purchased at Lowe's, Home Depot and various other locations. They are a slide which is glued to the veneer over the middle of the crack so that one side is attached on either side of the crack. They will crack if there is future movement which would warrant further investigation by a licensed engineer at that time):

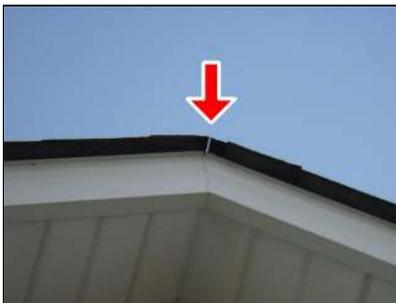
Front of home - above the garage - the apex shingle is cracked and needs to be repaired to prevent water entry behind the fascia. Contact a licensed contractor for review and make any additional repairs as needed.

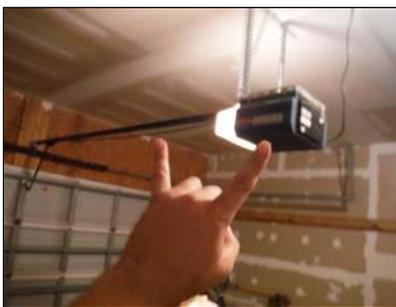
The following items were found to be in the need of repair and/or adjustment at the garage door during the inspection. Contact a licensed contractor for review and make any additional repairs as needed:

1. The auto reverse tension setting for the garage door did not function properly at the time of inspection. If the garage door were to hit something the door should automatically reverse. Most electric garage door openers now have an auto-reverse feature which acts to stop and reverse the door should some object (a child) be encountered while the door is closing. It is a safety protection device and its proper adjustment should not be neglected. Adjustment screws are generally labeled and within easy reach with a screwdriver. Contact a licensed contractor or garage door company for review and repair as needed.
2. The chain is loose and hanging down below the track. Adjust as needed

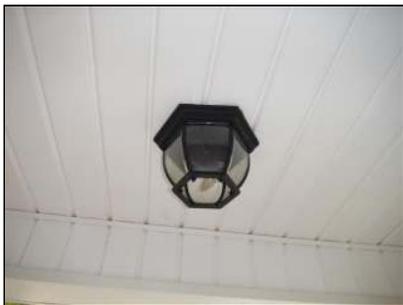
1

The following lights had a bulb that did not function when tested. Replace the bulb and re-test to be sure it functions and is not an electrical issue. Contact a licensed electrician if replacing the bulb does not correct the issue:

1. Front porch light
2. Master bedroom ceiling fan - one light missing bulb
3. Master bathroom can lights above the tub and shower areas
4. Upper, right, rear bedroom ceiling fan - one light missing bulb

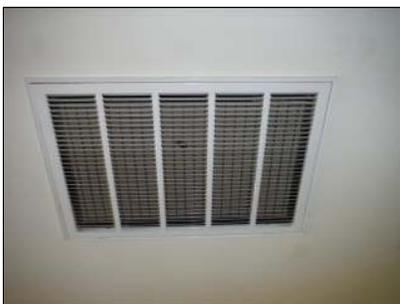
The air filter(s) were extremely dirty within the home. When filters are this dirty it is recommended that the interior components of the HVAC unit be serviced and cleaned as the clogged filter can allow dirt, lint and dander to coat and cover vital parts of the a/c system. Any other items in need of repair found when the HVAC contractor cleans the unit should also be addresses.

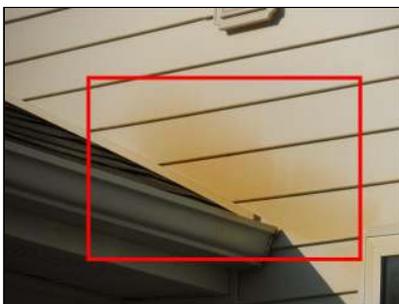
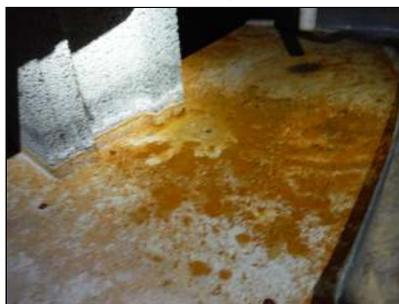
6.8 A/C System - Findings

The overflow pan under the HVAC unit in the attic has rust in it and there was rust stains on the sunroom roof below the secondary catch pan drain line. This is evidence that water was standing in the overflow pan at one point. There was no water in the pan at the time of inspection. Ask the seller the history of the rust and if the unit has been repaired? If they do not know it should be treated as an active issue and further evaluated by a licensed HVAC contractor.

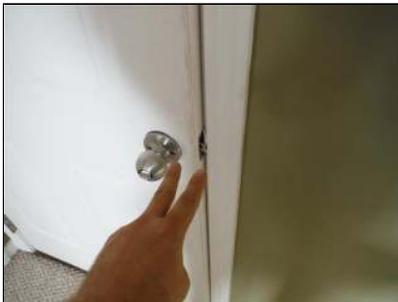
Garage house entry door - the door strike plate is over lapping the handle when closed and making it difficult to open/close the door. Adjustments are needed. Contact a licensed contractor for review and make any additional repairs as needed.

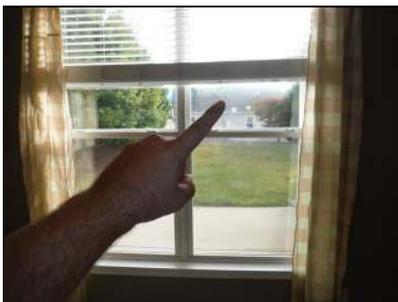
7.4 Window Findings

The following window(s) and/or sashes (but not limited to) were found to have a bad or broken thermal window seal. The thermal window seal is the gasket that prevents moisture from entering in between the interior of the window panes and causing them to fog. The window at this point has lost its gas thus reduces the original R-Value of the window: Note: All windows are located as if looking from the inside out toward the road or yard:

1. Rear living room - right rear window - upper sash
2. Sunroom - left wall - rear most window - upper sash
3. Formal living room - both front windows - both lower sashes
4. Master bedroom - front wall right window as you face the street - left window - both sashes
5. Upper, right, rear bedroom - both sashes
6. Upper, loft - left wall - lower sash

Note: Overcast days, dirty windows, and or rain can obstruct the view of the window or make it difficult to identify a bad thermal seal. Because of this It is recommend that all windows be cleaned and further evaluated by the licensed or qualified professional. Any additional windows that are found to have bad thermal seals at that time should also be repaired or replaced by a qualified professional.

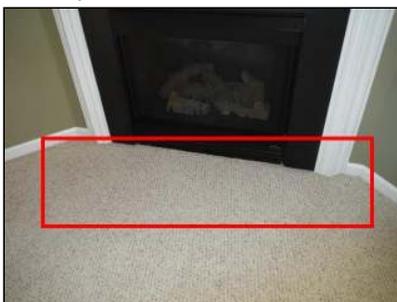
7.13 Fire Place Findings

There no hearth installed in front of the fire place. This is a fire safety hazard in need of repair. Contact a licensed contractor for review and make any additional repairs as needed.

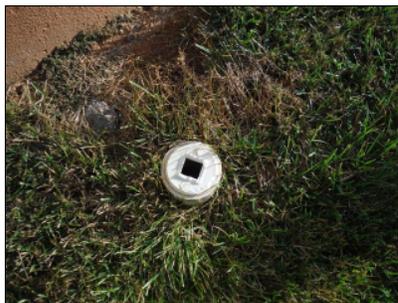
Right side of home - the waste pipe clean out cover is broken and needed to be replaced so that the cap can be removed and to prevent grass and pest entry from clogging the line. Contact a licensed contractor for review and make any additional repairs as needed.

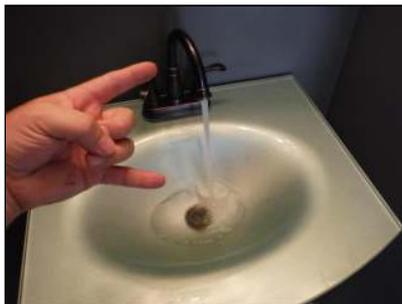
The sink stopper was missing the back half of the lever for the stopper under the sink and the connection rod between the stopper handle and the drain rod. Contact a licensed contractor for review and make any additional repairs as needed.

Stopper not working

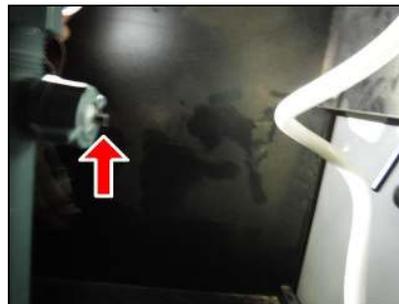
Missing pieces at tail pipe

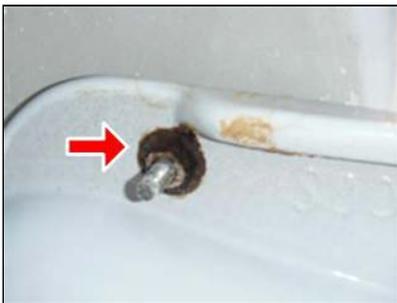
Left side of toilet - There were signs of a tank leakage noted on the bottom of the tank as seen by the stains and/or rust around the tank bolts. Repairs and or replacement of the tank may be needed. Note: Crack may result in over tightening the tank to the bowl, in this case the tank would need to be replaced.

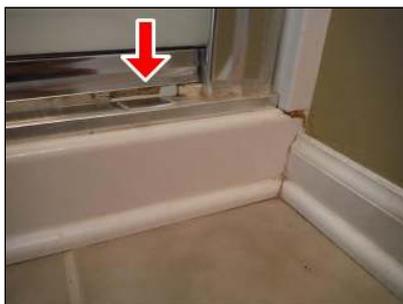
The weather stripping along the bottom of the door was torn and needed to be replaced. There was also some soft drywall at the lower, right exterior of the shower area indicating water exiting the shower door or frame area at some point. Contact a licensed contractor for review and make any additional repairs as needed.

Torn weather stripping

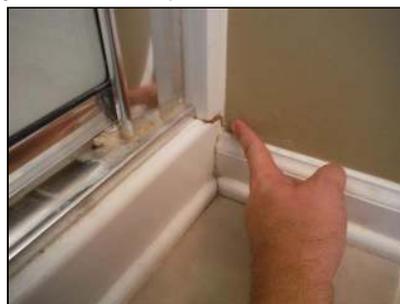
Soft drywall

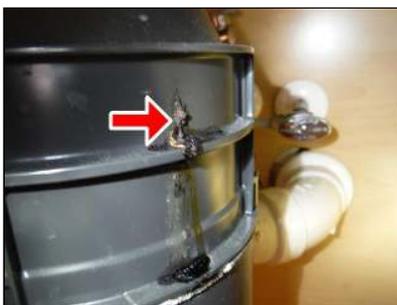
The disposal was cracked at the time of inspection and needed to be replaced. Contact a licensed contractor for review and make any additional repairs as needed.

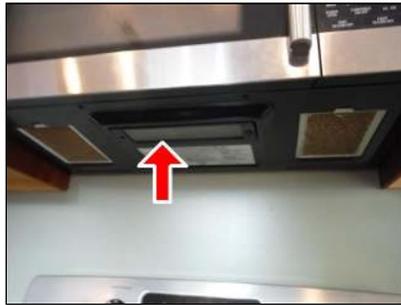
1

The following item(s) were noted to be in need of repair/replacement at the kitchen microwave at the time of inspection. Contact a qualified appliance repair person for review and make any additional repairs as needed:

1. The surface lights did not respond when tested at the time of inspection. Replace the bulb(s) and re-test to ensure that there is not a problem with the fixture itself. If the light does not function after replacement then contact a qualified professional for review and make any additional repairs as needed.
2. There were burn marks noted in the top of the microwave. The cause could not be determined, but this can be a sign that the unit has failed in some area and is in need of repair/replacement.

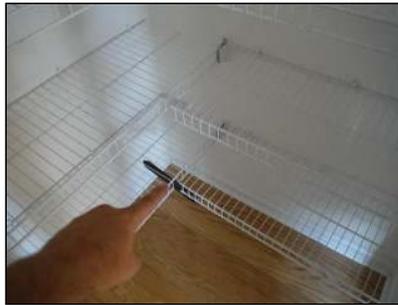
Pantry - lower shelf - the corner brace bracket was missing at the time of inspection. A piece of metal has been stuck in the area, but this is not a proper repair. Contact a licensed contractor for review and make any additional repairs as needed.

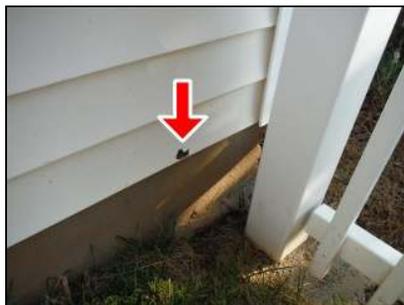
1

There were holes noted in the siding in the following locations. They need to be sealed/repaired/replaced as needed to prevent water penetration. Contact a licensed contractor for review and make any additional repairs as needed:

1. Right side of home - lower section near the rear corner of the house
2. Left side of home - lower section - several reas near the front corner of the home

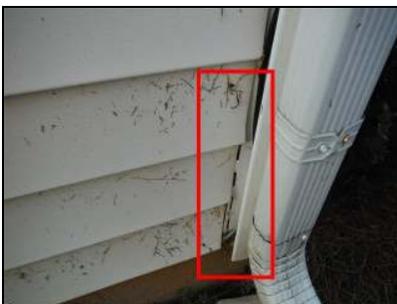
Left side of home - front corner - the corner piece is loose and needs to be re-secured to properly hold the vinyl siding in place. Contact a licensed contractor for review and make any additional repairs as needed.

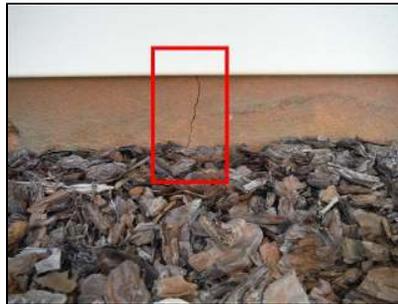
1.7 Foundation Findings

There was/were hairline crack(s) noted in the following locations. Point up and continue to monitor. No corresponding cracks were noted inside the home of these area and all windows and doors around the area were functioning as intended at the time of inspection.

1. Rear of home - right of the A/C unit (as you face the street)
2. Left wall of interior of the garage
3. Rear wall of the interior of the garage

(Please Note: - Glass monitoring kits can be purchased at Lowe's, Home Depot and various other locations. They are a slide which is glued to the veneer over the middle of the crack so that one side is attached on either side of the crack. They will crack if there is future movement which would warrant further investigation by a licensed engineer at that time):

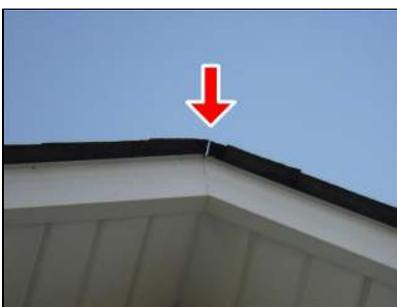
3.5 Roof Findings**Comments:** Repair or Replace

Front of home - above the garage - the apex shingle is cracked and needs to be repaired to prevent water entry behind the fascia. Contact a licensed contractor for review and make any additional repairs as needed.

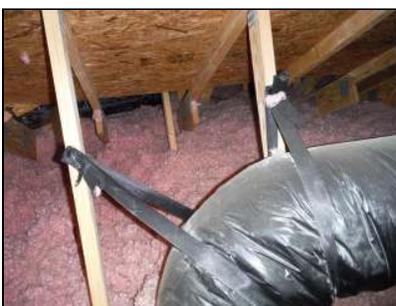
Could not access the attic area above the front bedrooms due to the roof sheathing preventing access

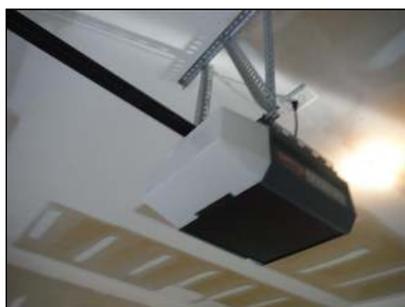
The garage door opener light did not function at the time of inspection. Replace the bulb and retest to ensure that there is not a problem with the fixture itself.

Light out

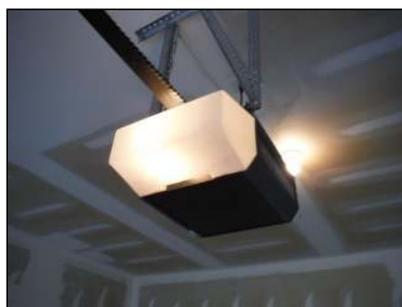
Replaced bulb

The above noted item was repaired at the time of inspection, as a courtesy, by America's Choice Inspections

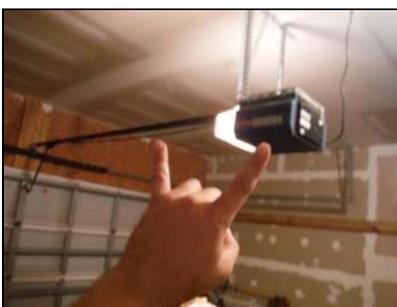
The following items were found to be in the need of repair and/or adjustment at the garage door during the inspection. Contact a licensed contractor for review and make any additional repairs as needed:

1. The auto reverse tension setting for the garage door did not function properly at the time of inspection. If the garage door were to hit something the door should automatically reverse. Most electric garage door openers now have an auto-reverse feature which acts to stop and reverse the door should some object (a child) be encountered while the door is closing. It is a safety protection device and its proper adjustment should not be neglected. Adjustment screws are generally labeled and within easy reach with a screwdriver. Contact a licensed contractor or garage door company for review and repair as needed.
2. The chain is loose and hanging down below the track. Adjust as needed

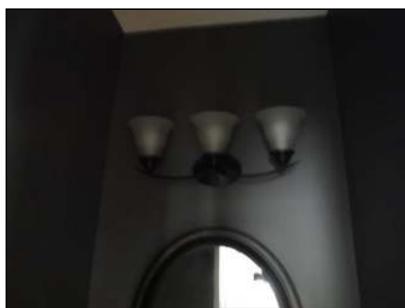
There were several lights out in the home at the time of inspection. The bulbs were replaced to be sure it was not an electrical issue. The lights responded once replaced. These were replaced as a courtesy by America's Choice Inspections.

1/2 bath light out

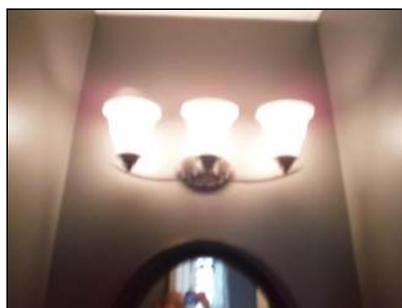
Replaced bulbs

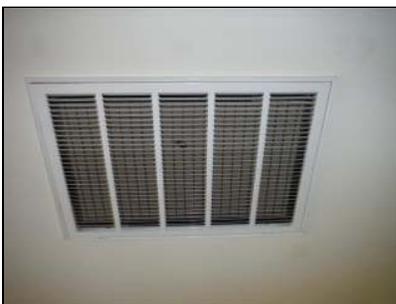
The air filter(s) were extremely dirty within the home. When filters are this dirty it is recommended that the interior components of the HVAC unit be serviced and cleaned as the clogged filter can allow dirt, lint and dander to coat and cover vital parts of the a/c system. Any other items in need of repair found when the HVAC contractor cleans the unit should also be addresses.

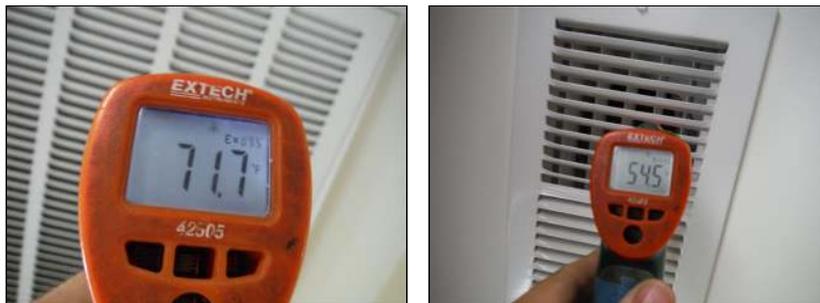
The ambient air test was performed by using thermometers on the air handler of 1st/Main Floor Unit: to determine if the difference in temperatures of the supply and return air are between 14 degrees and 22 degrees which indicates that the unit is cooling as intended. The supply air temperature on your system read 53 degrees, and the return air temperature was 71 degrees. This indicates the range in temperature is normal..

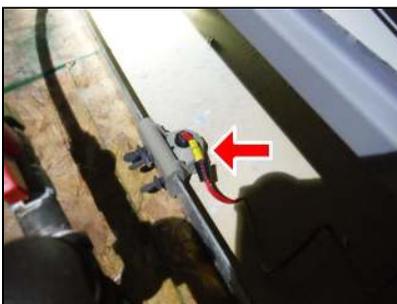
Float switch

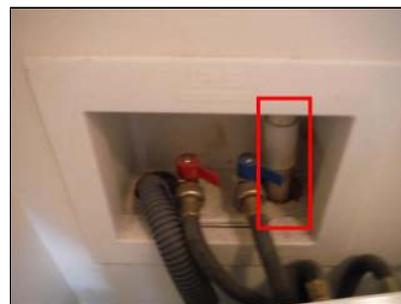
Main drain in laundry pipe

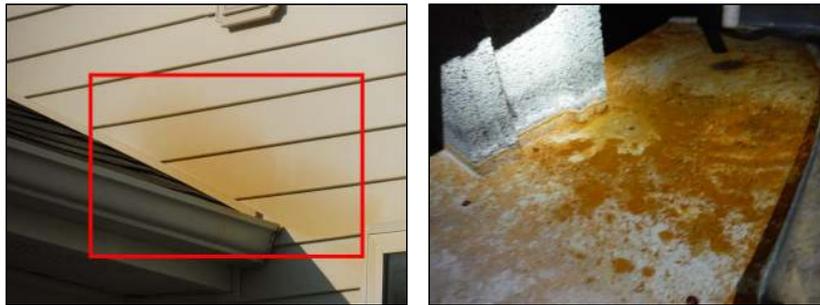
The overflow pan under the HVAC unit in the attic has rust in it and there was rust stains on the sunroom roof below the secondary catch pan drain line. This is evidence that water was standing in the overflow pan at one point. There was no water in the pan at the time of inspection. Ask the seller the history of the rust and if the unit has been repaired? If they do not know it should be treated as an active issue and further evaluated by a licensed HVAC contractor.

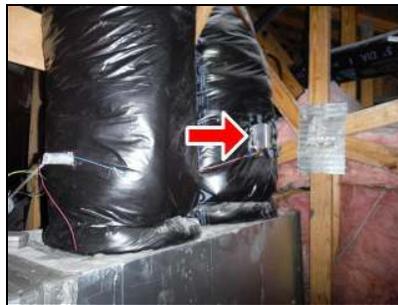
The inspector does not fully inspect dampener system. The parts are inside of the ductwork and invasive inspections are outside the scope of a home inspection. The inspector test to be sure that there is air flow on each floor and each register only. Unless otherwise noted in the report there was air flow to each floor and each register.

Dampener system installed

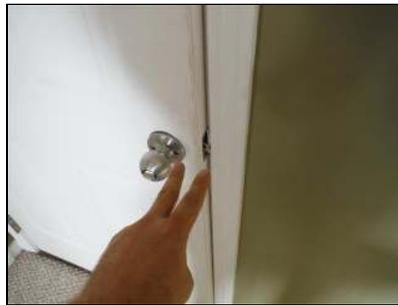
Garage house entry door - the door strike plate is over lapping the handle when closed and making it difficult to open/close the door. Adjustments are needed. Contact a licensed contractor for review and make any additional repairs as needed.

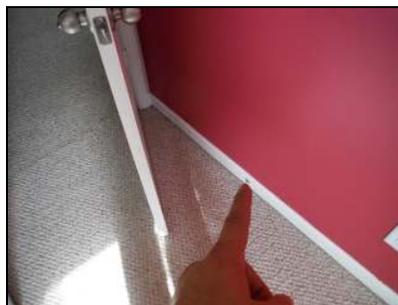
Missing door stopper noted at the upper bedroom

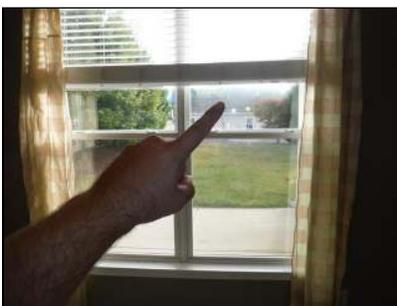
7.4 Window Findings

1. Rear living room - right rear window - upper sash
2. Sunroom - left wall - rear most window - upper sash
3. Formal living room - both front windows - both lower sashes
4. Master bedroom - front wall right window as you face the street - left window - both sashes
5. Upper, right, rear bedroom - both sashes
6. Upper, loft - left wall - lower sash

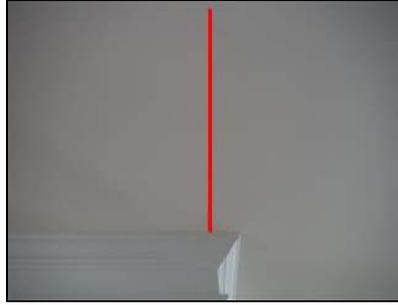
Hairline crack noted to the left of the formal living room column. Patch and continue to monitor.

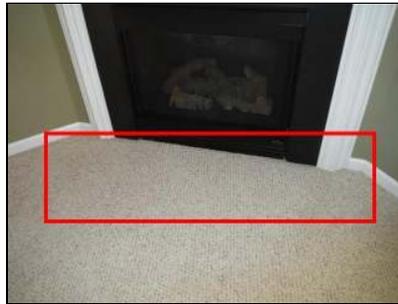
7.13 Fire Place Findings

There no hearth installed in front of the fire place. This is a fire safety hazard in need of repair. Contact a licensed contractor for review and make any additional repairs as needed.

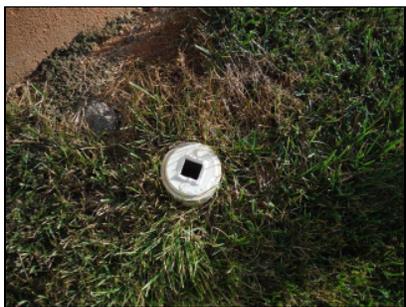
Right side of home - the waste pipe clean out cover is broken and needed to be replaced so that the cap can be removed and to prevent grass and pest entry from clogging the line. Contact a licensed contractor for review and make any additional repairs as needed.

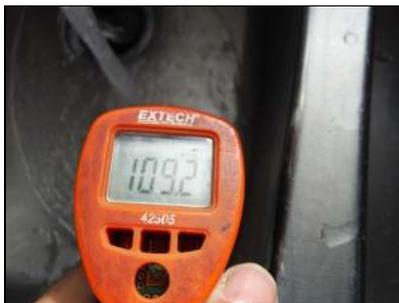
Water temperatures above 125 degrees can burn or scald. If temperatures are above 125 degrees is can generally be adjusted at the thermostat located behind the one or two service access doors on the front of the water heater. Some electric water heaters will have a control at the top of the tank. The water temperature at the time of inspection was 109 Degrees.

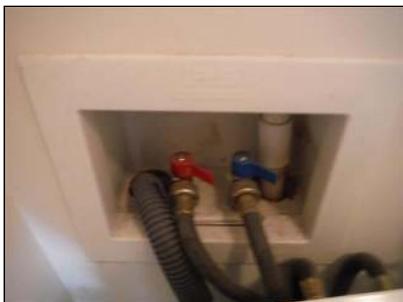
Note: There was not an overflow pan installed under the second floor washing machine unit. An overflow pan with a drain line is recommended in the event of a leak in the wash machine unit, but it is not a requirement

Not tested

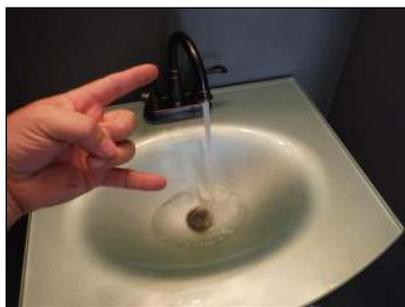
Stopper not working

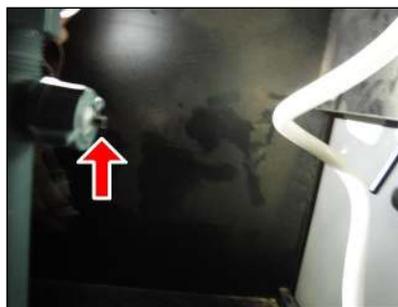
Missing pieces at tail pipe

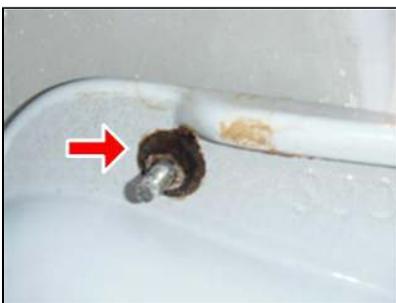
Left side of toilet - There were signs of a tank leakage noted on the bottom of the tank as seen by the stains and/or rust around the tank bolts. Repairs and or replacement of the tank may be needed. Note: Crack may result in over tightening the tank to the bowl, in this case the tank would need to be replaced.

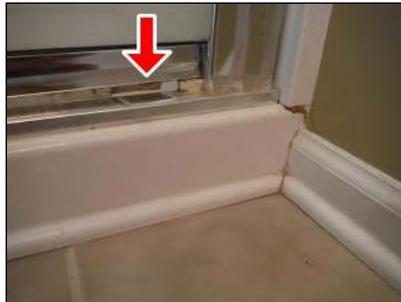
Torn weather stripping

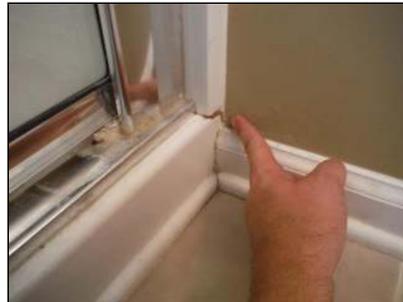
Soft drywall

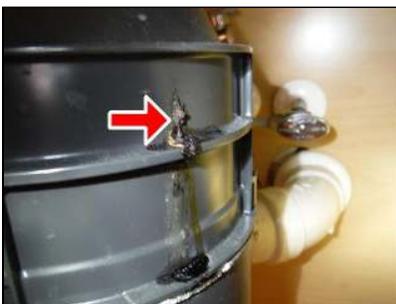
The disposal was cracked at the time of inspection and needed to be replaced. Contact a licensed contractor for review and make any additional repairs as needed.

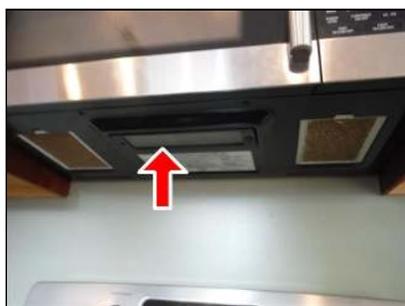
1

1. The surface lights did not respond when tested at the time of inspection. Replace the bulb(s) and re-test to ensure that there is not a problem with the fixture itself. If the light does not function after replacement then contact a qualified professional for review and make any additional repairs as needed.
2. There were burn marks noted in the top of the microwave. The cause could not be determined, but this can be a sign that the unit has failed in some area and is in need of repair/replacement.

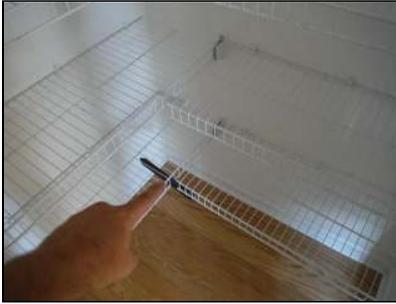
Pantry - lower shelf - the corner brace bracket was missing at the time of inspection. A piece of metal has been stuck in the area, but this is not a proper repair. Contact a licensed contractor for review and make any additional repairs as needed.
