Inspection Report

Property Address:
1234 Money Well Spent Ln.
Charlotte NC

Americas Choice Inspections
PO Box 49271
Charlotte, NC 28277

Date: 10/5/2013	Time: 02:00 PM	Report ID:
Property: 1234 Money Well Spent Ln. Charlotte NC	Customer: Mr. Rent to Buy	Real Estate Professional:

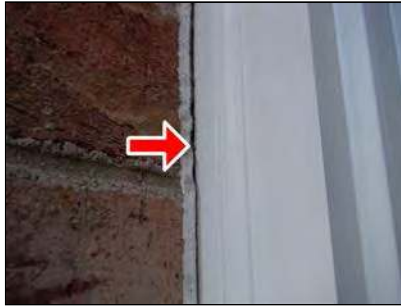
1.4 Trim Findings

Sealant is needed to fill gaps which were noted where the trim meets different materials. This is needed to prevent water penetration at the following locations. This will be yearly maintenance once you close on the home. Contact a licensed contractor for review and make any additional repairs as needed:

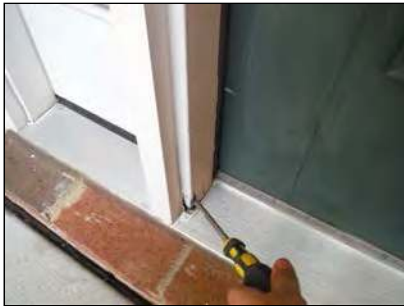
1

1. Wood rot at the lower, left corner of the front door
2. Termite damage at the lower, right corner of the front door which has been puttied over
3. Termite damage at the lower, right inner frame of the front door

(1) Due to the following areas, but not limited too, contact a licensed termite company for treatment and a licensed contractor to determine the extent of any damages and make all repairs as needed:

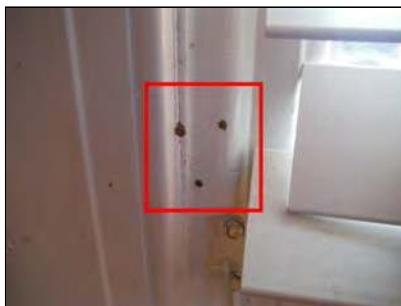
4

4. Termite holes noted inside the house at areas of the window-lite area
5. Termite holes noted at the formal dining room baseboard near the foyer corner

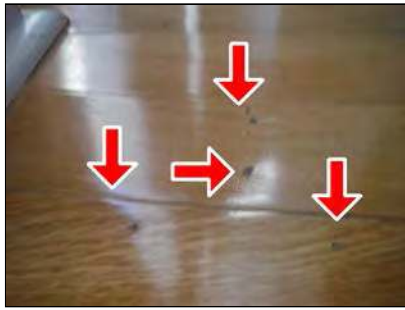
6

6. Termite holes noted in the foyer to formal dining hardwoods.
7. Termite damage noted to the front band sill below the front door
8. Termite tubs noted at the double joist between the right side of the front porch and the first girder/beam they meet.

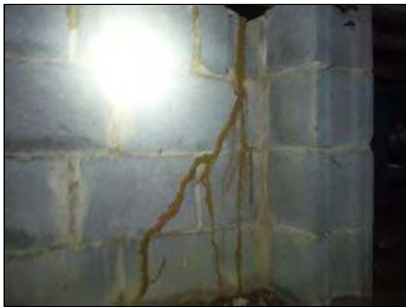
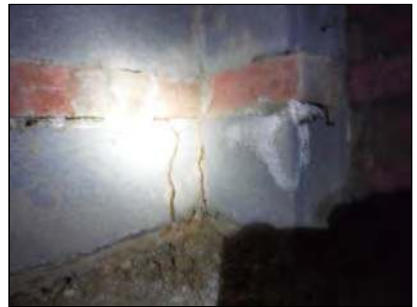
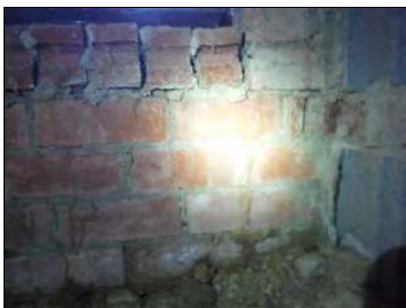
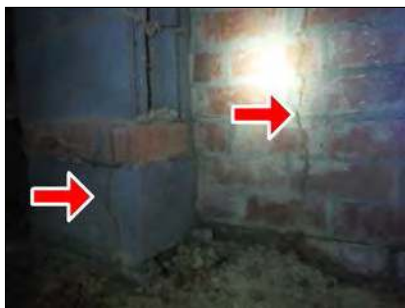
9

9. Several termite tubes noted at the front door area, the left side of the porch (as you face the street) and at the first pier to the left of the porch (as you face the street) There were also tubes noted front band pieces from the porch to the formal dining pier previously noted.

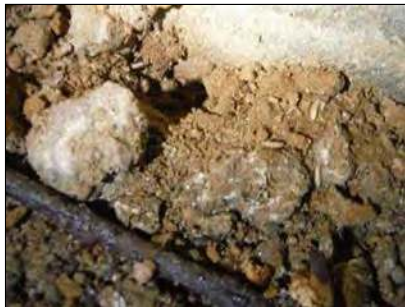
Active termites

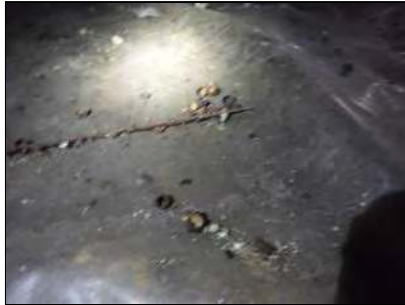
(3) Below the master whirlpool tub - when the insulation was pulled back around the waste pipe for the tub nuts fell out of the area. Ask the seller if a pest was dealt with in the past. If not, it should be treated as an active issue reviewed by a licensed exterminator.

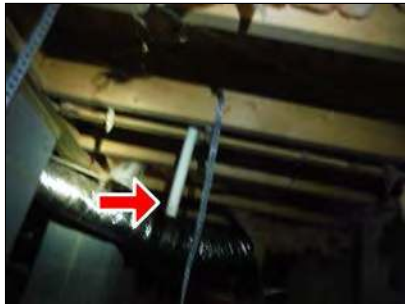
(4) Front, middle of the crawl space - there was a drain line terminated in this area (Possibly for the attic water heater catch pan) Drain should not terminate in the crawl space as they create an unwanted condition when in use and also prevents you from knowing when there is an issue. The drain should be extended to daylight. Contact a licensed contractor for review and make any additional repairs as needed.

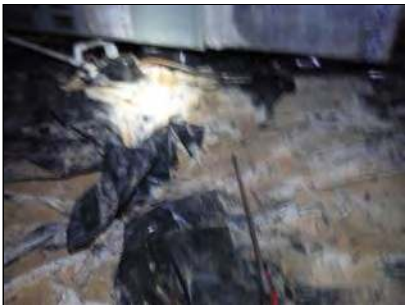
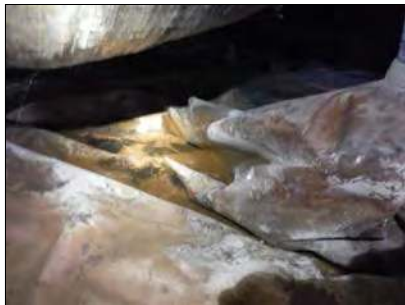
2.5 Moisture / drainage

There are signs of water entry under the home front the right side of the house over to the left side of the home. The source of the water needs to be determined and correction made to stop the issue. (See exterior grading as possible source) Contact a licensed crawl space ceiling company to review and make repairs as needed.

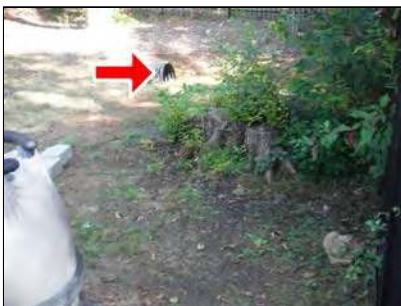
Neighbors drain

The grade at foundation needs correction at the right. The grade slopes toward the home and needs correction or properly drainage installed to direct water away from the foundation. The tenant also noted that large amounts of water travel across the rear of the home and stand at the left, rear yard. It was noted that the neighbor has installed a pool and changed the original grading of the lot. There is a large drain at in that yard at the right, rear corner. This may be the cause of the pooling water. Corrections are needed so that the lot will drain properly.

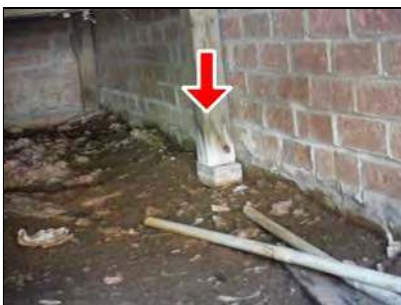
Below sunroom

It was also noted that water is pooling under the rear sunroom as noted by the stains on the wall and post. Have a licensed contractor or professional landscaper review and make the necessary corrections as needed. (see crawl space notes also)

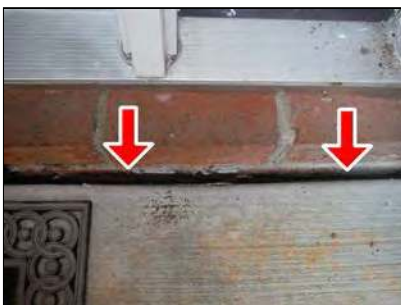
3.2 Front Porch Findings

There is a large gap between the front porch stoop and the house wall. This can allow water penetration along this area. Have a licensed contractor for review and make any additional repairs as needed.

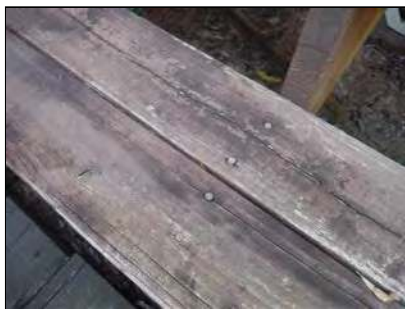
2

1. Various deck boards are cupping and/or loose. Protruding screw heads are also a safety hazard.
2. The staircase treads show signs of moisture damage and needed to be re-sealed.
3. The staircase stringers are not fully supported at the deck ledger. This can allow the stringers to split over time.

(1) The following items were noted in need of repair and/or correction at the time of inspection. It is recommended that a licensed contractor review the entire deck and make any additional repairs as needed:

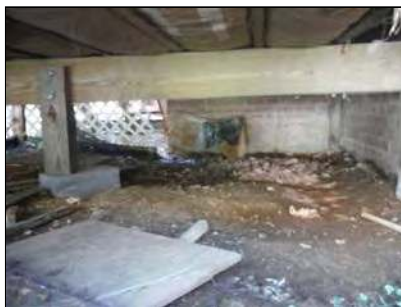
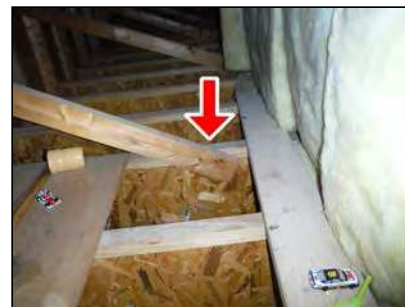
2

- post is not centered on the CMU block installed and the girder is not bolted to the current post at all connections
2. The bonus room attic tie back area nailed into the top flange of the I-joist. This can cause the flange to be disconnected as they are not designed for this force to be applied. I-joists generally require full decking to distribute loads and prevent point loading.

(1) Due to the following, but not limited too, contact a licensed engineer for further evaluation of the entire structure. Make any additional repairs as deemed necessary in their report:

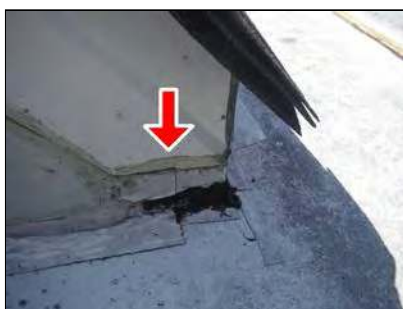
1. The rear addition roof is not flashed to the house in a typical fashion. A tar tape product is in use and there was no flashing at the left corner (as you face the street) There are signs of leaks noted inside the sunroom above the entry door (and the tenant said it does leak), at the rear soffit area and at the left side soffit area (as you face the street)
2. The rear addition roof has gaps at the seams running from front to rear. This can allow water penetration and needs to be corrected.
3. Garage - above the rear side of the garage door - there was a moisture stain at this area. There were no active readings at the time of inspection, but there has been no rain lately. Inside the attic above this area the sub-roof is stained at the house corner. There is also a "hard corner" above this area where the water from the

No flashing to brickwork

(2) The following items were noted in need of repair and/or replacement on the roof. Contact a licensed roofing contractor for further evaluation and make any additional repairs as needed:

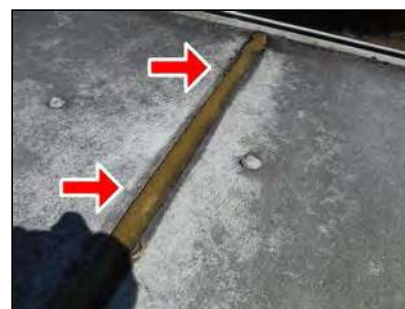
Tar tape flashing to fascia

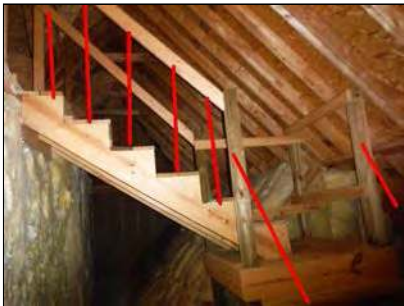
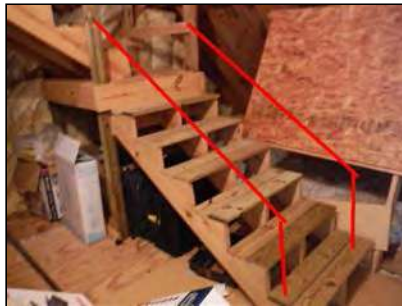
1

(1) There are various safety hazards noted in the attic areas which were in need of repair. Contact a licensed contractor for review and make any additional repairs as needed:

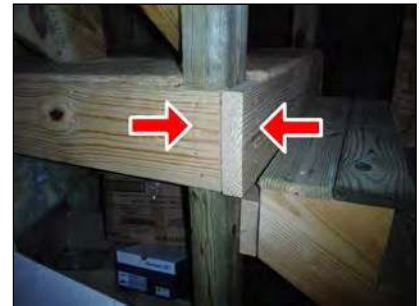
2

2. The staircase landing is not bolted to the post, only nailed which can pull loose.
3. Neither set of staircase stringers are secured to the ledgers properly. There is no ledger is hanger where they connect.

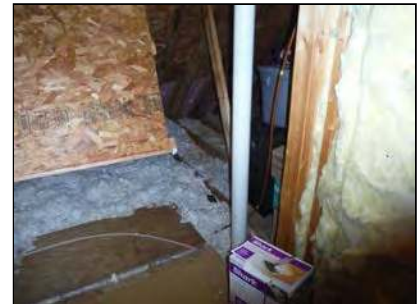
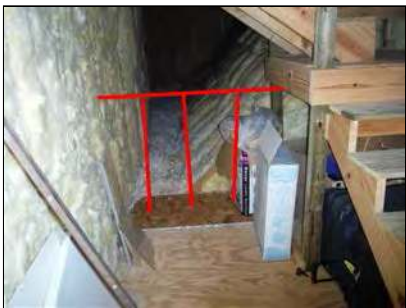
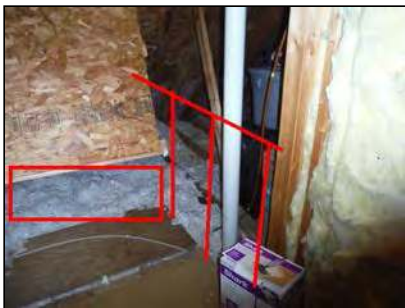
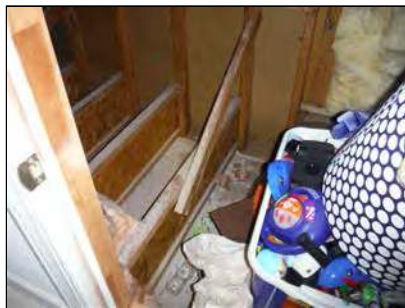
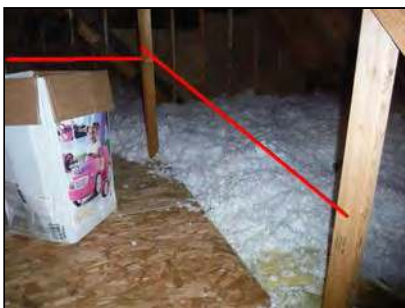
4

4. The bonus room attic and the upper attic areas do not have flooring or guard rails installed at either the entry door and/or off floored areas of the attic. This is a child safety hazard as kids open doors and go inside when playing and do not know that the sheet rock will not hold their weight. This allows the child to fall through the ceiling and into the room below causing serious and sometime fatal injury. It is recommended to install flooring or installed a locked handle to prevent children from entering.

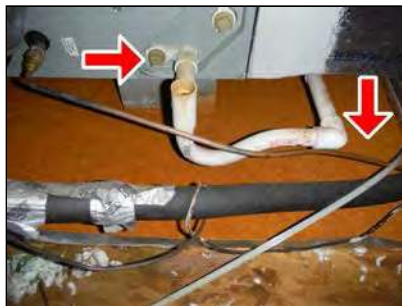
2,3

2. There was rust in the catch pan. This is an indication of the primary line being clogged at some point. The unit was off when I arrived and only ran for about an hour which is often not long enough to see if this is still an active issue. Ask the seller if a previous repair was made, if not it should be treated as an active issue in need of further evaluation.

3. Horizontal Install - There is a not a secondary drain line installed at the bottom of the evaporator coil. The secondary drain line is needed in the event that the main condensate drain line becomes clogged. This will allow water to drain into the pan below indicating that there is a problem or issues with the unit. Without the secondary drain line the water may rise to heights within the coil box causing rust/damage. A secondary drain

line is recommended or sensor switch on the main drain line installed. The sensor will also shut down the unit if the primary line clogs to prevent damage

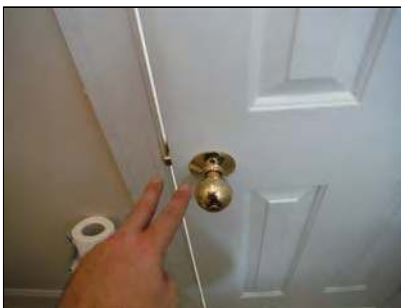
(1) The strike plates need to be adjusted at the following doors. Currently the door handle does not need to be turned for the door to be opened:

1. Master bathroom toilet closet door

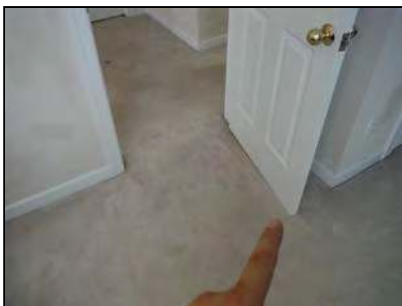
Entry door

(2) The upper, front, left bedroom entry and closet door(s) were rubbing the carpet and need to be adjusted. This causes premature wear to the carpeting, makes opening and closing the door difficult and also prevents the HVAC unit from allowing air travel between the rooms adequately. Contact a licensed contractor for review and make repairs as needed.

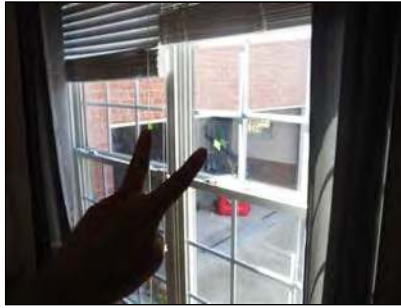
(1) The following window(s) and/or sashes (but not limited to) were found to have a bad or broken thermal window seal. The thermal window seal is the gasket that prevents moisture from entering in between the interior of the window panes and causing them to fog. The window at this point has lost its gas thus reduces the original R-Value of the window: Note: All windows are located as if looking from the inside out toward the road or yard:

1. Formal dining room - both upper sashes
2. Master bedroom - rear wall - right window - upper sash
3. Living room - both upper sashes
4. Formal living room - both upper sashes and possibly the half round
5. Sunroom - rear wall - rear wall - 2nd window to the left of the right corner and the far left window
6. Upper, left bedroom - front wall - both upper
7. Bonus room - front window - both sashes

Note: Overcast days, dirty windows, and or rain can obstruct the view of the window or make it difficult to identify a bad thermal seal. Because of this It is recommend that all windows be cleaned and further evaluated by the licensed or qualified professional. Any additional windows that are found to have bad thermal seals at that time should also be repaired or replaced by a qualified professional.

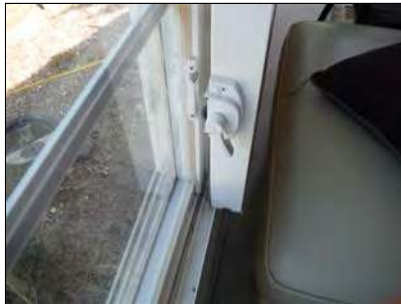
(3) Sun room - rear wall - middle window - the window is out of the track guide and needs to be repaired so that the window can be locked and prevent unwanted entry. Contact a licensed contractor for review and make any additional repairs as needed.

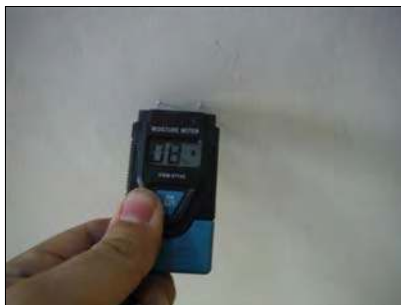
(1) There was an active moisture leak noted at the Kitchen near the sink area. This is below an upper bathroom. The reading was 8%. Contact a licensed contractor for review, determine the source/cause and make any additional repairs as needed.

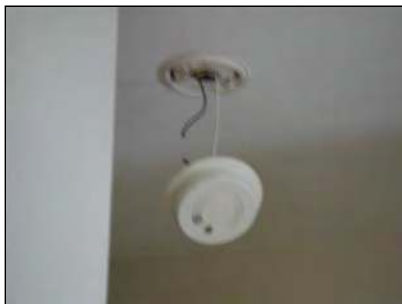
(2) The smoke detector outside the master bedroom was hanging loose from the ceiling and one of the wires has been cut. Contact a licensed electrician for review and make any additional repairs as needed.

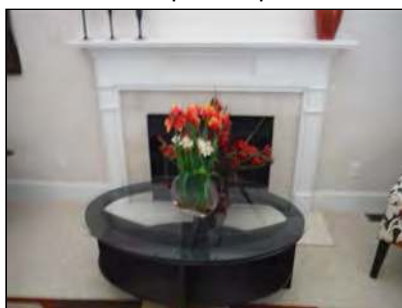
The pilot light was not lit at the time of inspection. Pilot lights must be lit at the time of inspection for the inspector to test them. If the unit has been off for some it can take a long time to get them to light and/or the air in the lines often need to be bled. The inspector does not carry lighting matches/lighters to lit units that do not have a auto igniter either. It is recommended that the pilot be lit and the unit be inspected prior to closing.

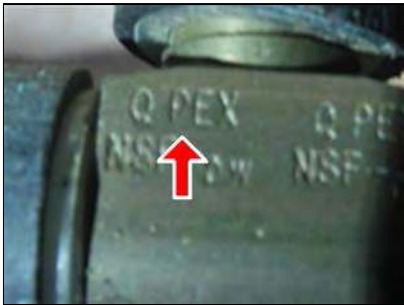
failures and leaks in its QPEX fittings. The client should visit the class action settlement website for more information, www.PlumbingFittingSettlement.com. A licensed plumbing contractor should be consulted for a complete inspection of the plumbing system and to make recommendations for repairs.

Multiple fittings in the crawl space show signs of failure as seen by the build up around the outside of the fitting and that can be seen through the translucent PEX on the interior.

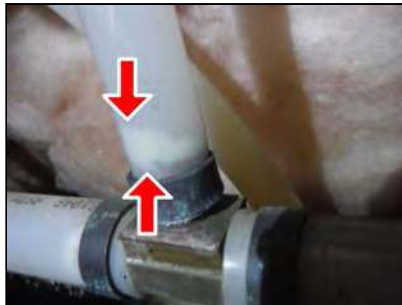
Build up inside pipe

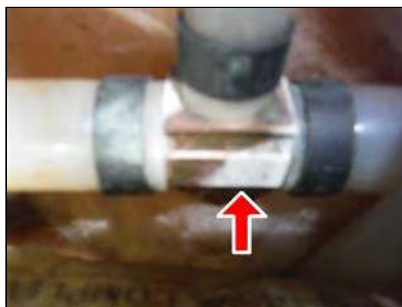
Corrosion on exterior of fitting

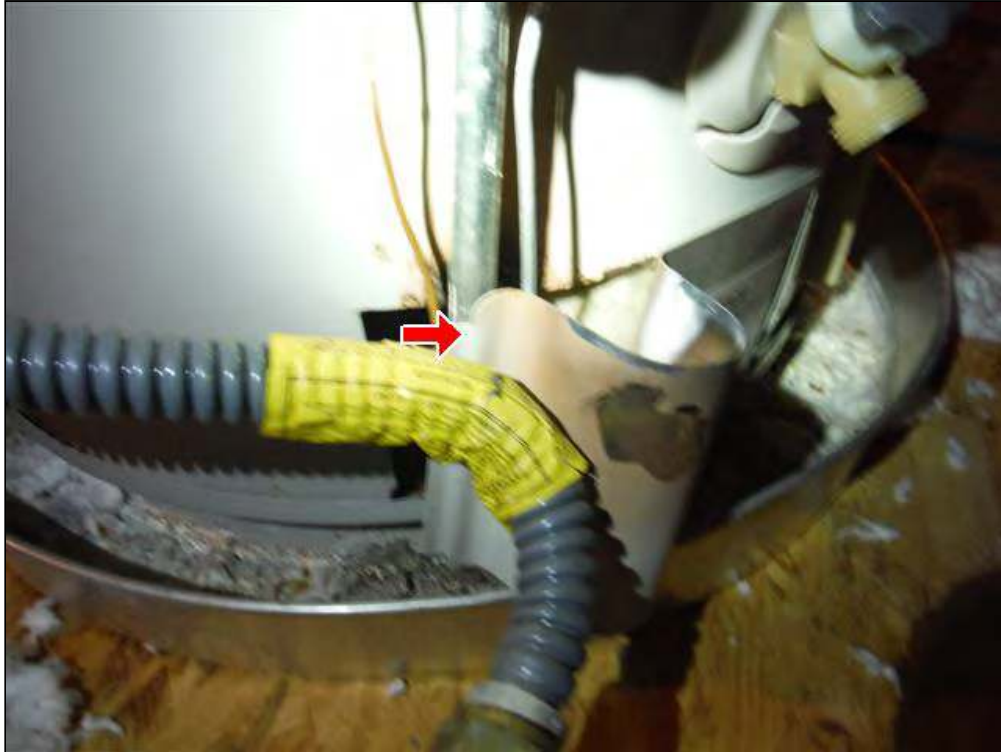
2

Due to the following, but not limited to, it is recommended that a licensed plumbing contractor further evaluate the water heater and make any additional repairs needed:

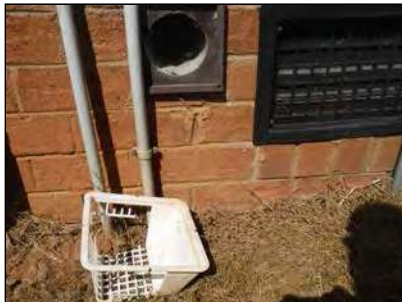
(1) Right side of home - the dryer vent cover was off at the time of inspection needed to be repaired. The flap was also missing. Contact a licensed contractor for review and make any additional repairs as needed.

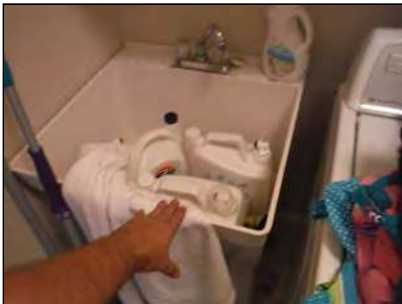
(2) The laundry room sink needs to be properly secured to the walls/floor. Currently the waste pipe and/or supply pipes are all that are holding it in place. If someone were to grab or hit the sink it could dislodge a pipe. Contact a licensed contractor for review and make any additional repairs as needed.

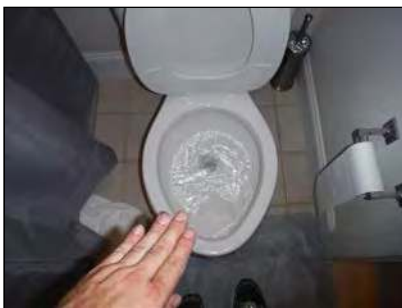
The toilet is loose at the floor and needs to be secured properly to prevent movement and or possible leakage. Note: A new wax ring should be installed under all loose toilets. As the toilet loosens the seal that is formed from the toilet loosens and the seal is not as tight as it once was. This may result in a leak allowing waste water or sewage gases into the home from a deformed wax ring. Contact a licensed plumber for review and make any additional repairs as needed.

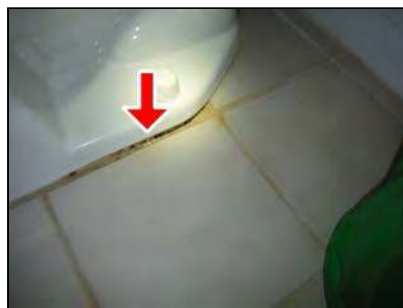
1

1. There are gaps around the tiles at the base of the toilet and the toilet itself. This can allow water to travel under the toilet as people get in and out of the shower or during mopping. The gap needs to be sealed.
2. The toilet continues to run after it has been flushed. The inlet valve float is not adjusted at a proper height and needs adjustment/replacement so that toilet will stop running when not in use.

The following items were noted to be in need of repair and or corrections at the bathroom toilet at the time of inspection. Contact a licensed contractor or plumber for review and make any additional repairs as needed:

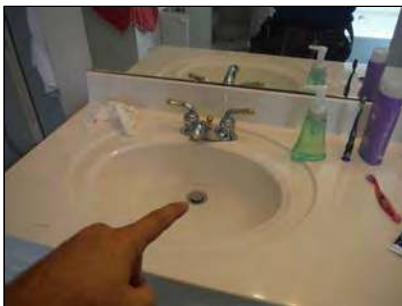
Right sink - The sink drains slow, corrections needed for the sink to drain properly. Clean the drain and re-inspect. If the sink is still slow to drain it could possibly be a venting issue. Contact a licensed contractor or plumber for further evaluation if cleaning the drain does not correct the issue.

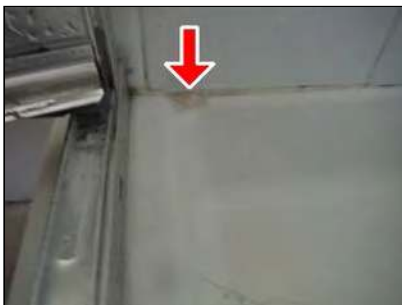
(1) The weep holes at the base of the shower wall have been sealed. These holes should be left unsealed to allow any condensation that may get behind the walls to drain back into the basin. Please Note: - There are two small holes at the front left and right corners of the shower unit or pan. They are weep holes designed to allow condensation to drain back into the shower pan/basin that may become trapped behind tiles/marble surrounds. When these holes are sealed or caulked you may possibly see water stains on a ceiling below due to the condensation becoming trapped and not being able to drain back into the shower pan/basin.

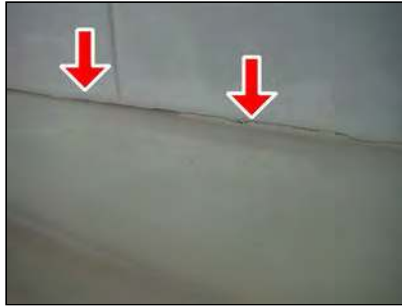
(2) Several areas in the tub/shower surround that were noted in need of additional grout or re-grouting to sealed properly and prevent water penetration.

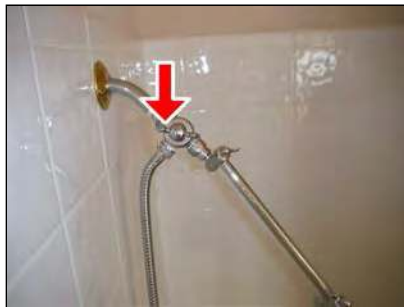
1

1. Shower - There was a leak noted at the back of the shower head where it connects to the plumbing pipe. Repairs are needed to prevent water damage. This can often be as simple as adding additional teflon tape but could possibly be from a bad gasket at the ball inside the fixture or a cracked shower head. Contact a licensed contractor for review and make any additional repairs as needed.
2. Tub - the hot/cold handles are installed reverse of each other. This makes it confusing to turn the water off once on and needs to be corrected.

The following items were noted to be in need of repair and or corrections at the bathroom shower/tub fixtures at the time of inspection. Contact a licensed contractor for review and make any additional repairs as needed:

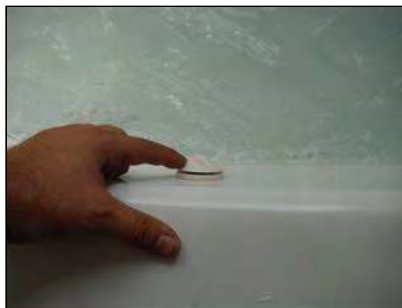
The air valve at the front, right side of the tub did not function at the time of inspection. This is needed for you to be able to adjust the "bubbles" in the tub as it allows more or less air in. Contact a licensed plumber for review and make any additional repairs as needed.

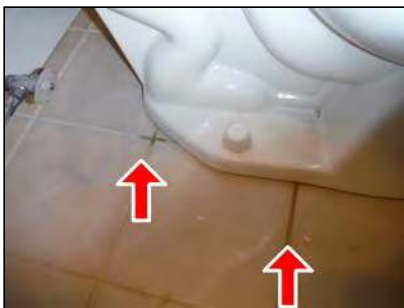
1

1. Staining or discoloration was noted on the floor around the toilet. This is indication that the toilet is leaking or has leaked in the past. Ask the sellers the history of the toilet and leaks that may have occurred. If the seller is unaware of the staining or discoloration then the toilet should be considered of having an active leak. Have a licensed plumbing contractor further evaluate the toilet and have a licensed general contractor further evaluate the flooring to ensure that there is not additional hidden or concealed damage. (See ceiling notes as possible source)
2. The toilet did not flush properly at the time of inspection. The handle must be held down to get a full flush.

The following items were noted to be in need of repair and or corrections at the bathroom toilet at the time of inspection. Contact a licensed contractor or plumber for review and make any additional repairs as needed:

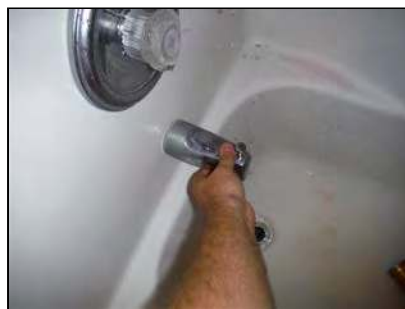
2

1. The drain stopper was missing at the time of inspection. Replacement is needed so the tub can hold water properly when bathing.
2. The tub spout is loose in the wall and there is a large gap when the diverter is used. Gaps of this type and size should not be caulked as the caulk will just pull away from the wall. The spout needs to be secured properly to prevent water penetration behind the wall.

The following items were noted to be in need of repair and or corrections at the bathroom shower/tub fixtures at the time of inspection. Contact a licensed contractor for review and make any additional repairs as needed:

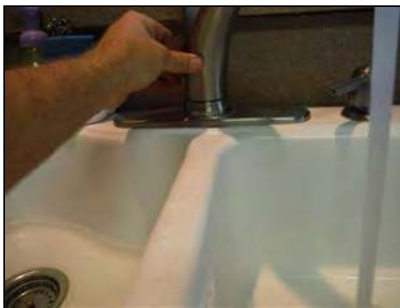
The sink faucet is loose at the base connection and needed to be re-secured. Contact a licensed contractor for review and make any additional repairs as needed.

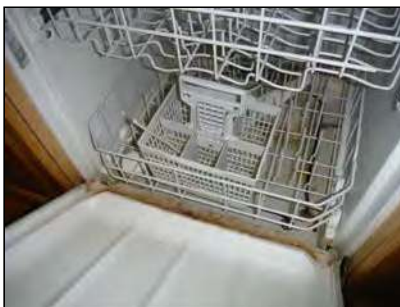
The unit filled, but would not drain or wash. Contact a qualified appliance repair person review and repair/replace as needed.

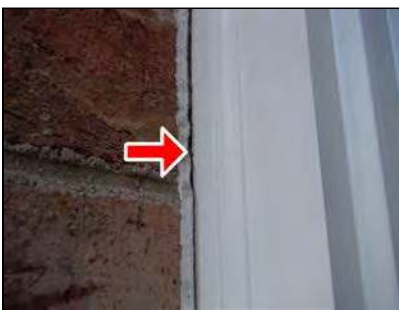
Sealant is needed to fill gaps which were noted where the trim meets different materials. This is needed to prevent water penetration at the following locations. This will be yearly maintenance once you close on the home. Contact a licensed contractor for review and make any additional repairs as needed:

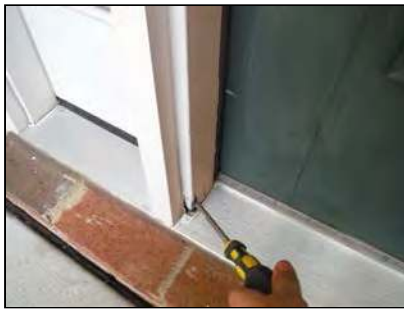
1

1. Wood rot at the lower, left corner of the front door
2. Termite damage at the lower, right corner of the front door which has been puttied over
3. Termite damage at the lower, right inner frame of the front door

(1) Due to the following areas, but not limited too, contact a licensed termite company for treatment and a licensed contractor to determine the extent of any damages and make all repairs as needed:

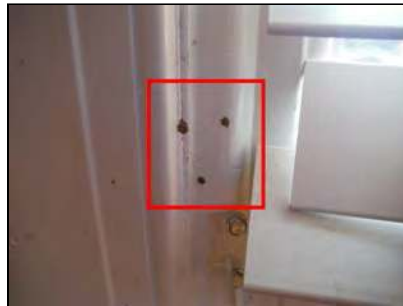
4

4. Termite holes noted inside the house at areas of the window-lite area
5. Termite holes noted at the formal dining room baseboard near the foyer corner

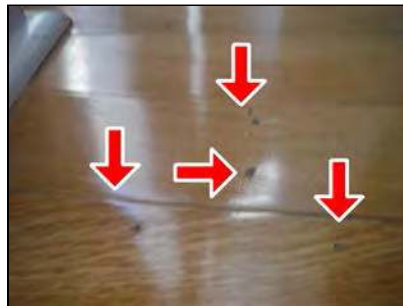
6

6. Termite holes noted in the foyer to formal dining hardwoods.
7. Termite damage noted to the front band sill below the front door
8. Termite tubes noted at the double joist between the right side of the front porch and the first girder/beam they meet.

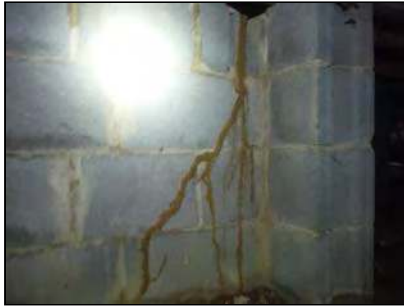
9

9. Several termite tubes noted at the front door area, the left side of the porch (as you face the street) and at the first pier to the left of the porch (as you face the street) There were also tubes noted front band pieces from the porch to the formal dining pier previously noted.

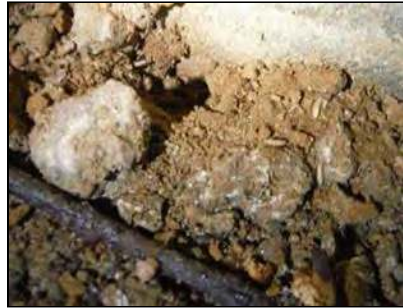
Active termites

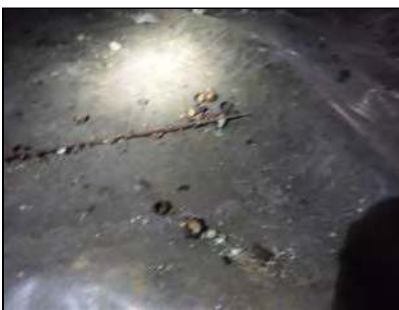
(3) Below the master whirlpool tub - when the insulation was pulled back around the waste pipe for the tub nuts fell out of the area. Ask the seller if a pest was dealt with in the past. If not, it should be treated as an active issue reviewed by a licensed exterminator.

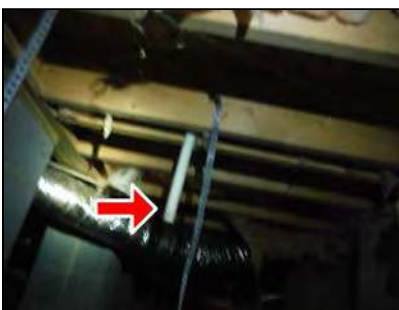
(4) Front, middle of the crawl space - there was a drain line terminated in this area (Possibly for the attic water heater catch pan) Drain should not terminate in the crawl space as they create an unwanted condition when in use and also prevents you from knowing when there is an issue. The drain should be extended to daylight. Contact a licensed contractor for review and make any additional repairs as needed.

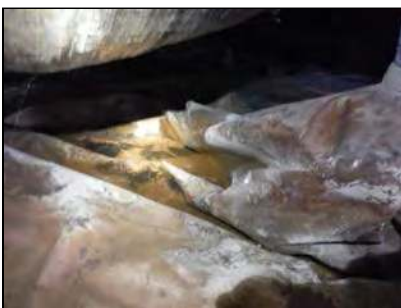
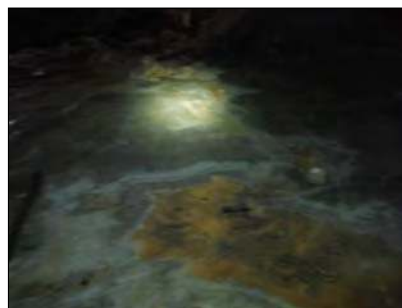
There are signs of water entry under the home front the right side of the house over to the left side of the home. The source of the water needs to be determined and correction make to stop the issue. (See exterior grading as possible source) Contact a licensed crawl space ceiling company to review and make repairs as needed.

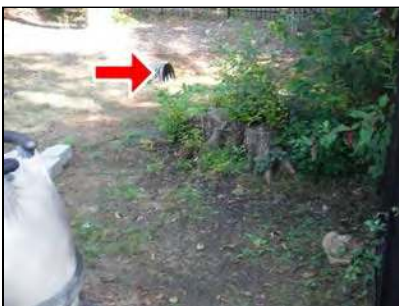
Neighbors drain

The grade at foundation needs correction at the right. The grade slopes toward the home and needs correction or properly drainage installed to direct water away from the foundation. The tenant also noted that large amounts of water travel across the rear of the home and stand at the left, rear yard. It was noted that the neighbor has installed a pool and changed the original grading of the lot. There is a large drain at in that yard at the right, rear corner. This may be the cause of the pooling water. Corrections are needed so that the lot will drain properly.

It was also noted that water is pooling under the rear sunroom as noted by the stains on the wall and post. Have a licensed contractor or professional landscaper review and make the necessary corrections as needed. (see crawl space notes also)

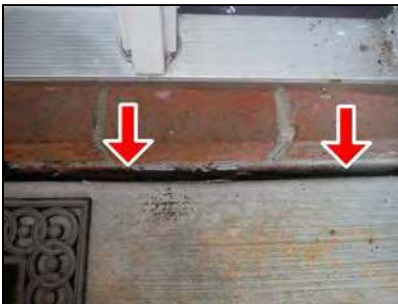
There is a large gap between the front porch stoop and the house wall. This can allow water penetration along this area. Have a licensed contractor for review and make any additional repairs as needed.

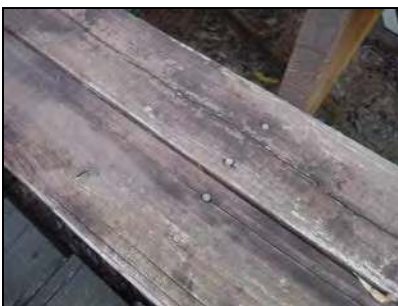
2

1. Various deck boards are cupping and/or loose. Protruding screw heads are also a safety hazard.
2. The staircase treads show signs of moisture damage and needed to be re-sealed.
3. The staircase stringers are not fully supported at the deck ledger. This can allow the stringers to split over time.

(1) The following items were noted in need of repair and/or correction at the time of inspection. It is recommended that a licensed contractor review the entire deck and make any additional repairs as needed:

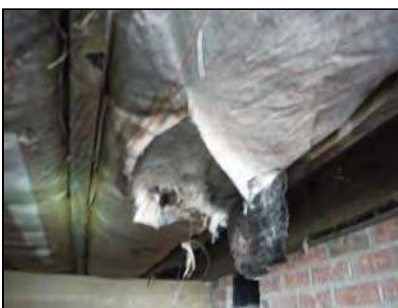
(2) Below the sunroom - the insulation is installed backwards. This locks moisture inside the room not out of it. There were also signs of a pest living in an area of the insulation near the left corner of the home. Contact a licensed contractor for review and make repairs as needed.

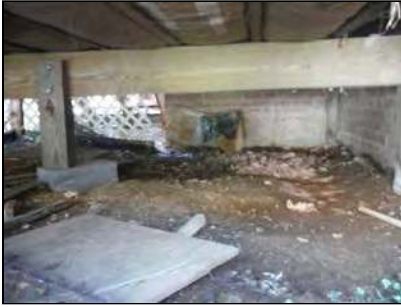
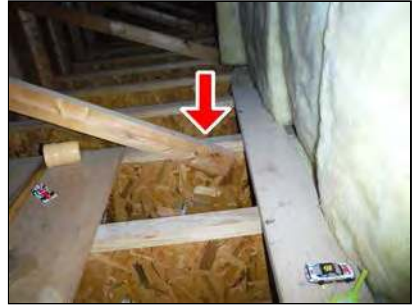
2

2. The bonus room attic tie back area nailed into the top flange of the I-joist. This can cause the flange to be disconnected as they are not designed for this force to be applied. I-joist generally require full decking to distribute loads and prevent point loading.

- (1) Due to the following, but not limited too, contact a licensed engineer for further evaluation of the entire structure. Make any additional repairs as deemed necessary in their report:

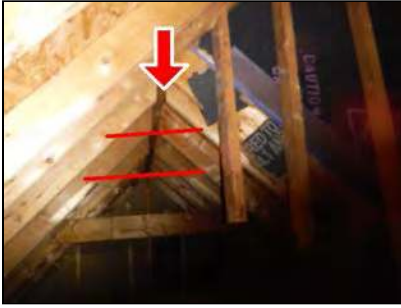
9

9. Upper attic - front gable to your left as you face the street - there was only 1 rafter tie in this area. Generally there is one on every other rafter to tie the two sides of the gable together and prevent them from sagging. The rear of the ridge is also not posted which can allow this end of the ridge to sag/fail.

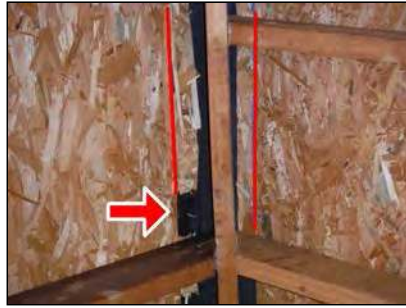
11

11. There was not a adequate amount of sheathing used at the ridge vent area. This has caused the sections to crack, split and or fall. This leaves the ridge vent improperly secured to the roof and could come off in a wind storm.

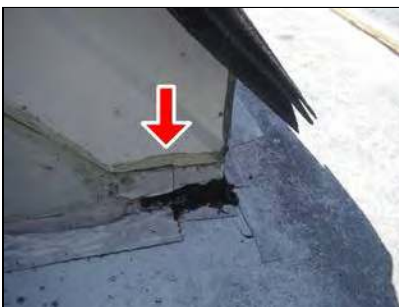
1. The rear addition roof is not flashed to the house in a typical fashion. A tar tape product is in use and there was no flashing at the left corner (as you face the street) There are signs of leaks noted inside the sunroom above the entry door (and the tenant said it does leak), at the rear soffit area and at the left side soffit area (as you face the street)

Tar tape flashing to fascia

(2) The following items were noted in need of repair and/or replacement on the roof. Contact a licensed roofing contractor for further evaluation and make any additional repairs as needed:

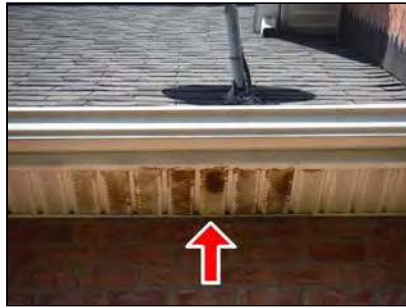
4

4. Right side of the garage roof - there are water stains at the soffit below the satellite dish. In the attic above this area the sub-roof is also stains at the roof screw penetrations.

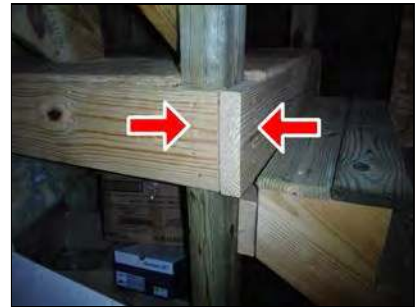
2

2. The staircase landing is not bolted to the post, only nailed which can pull loose.
3. Neither set of staircase stringers are secured to the ledgers properly. There is no ledger is hanger where they connect.

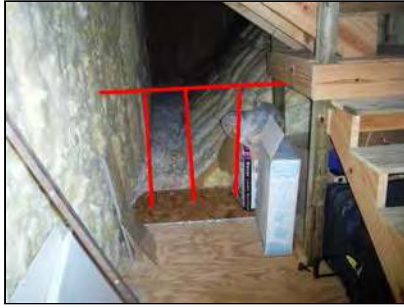
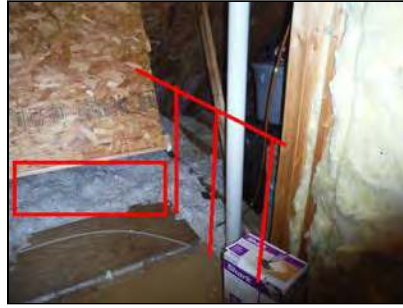
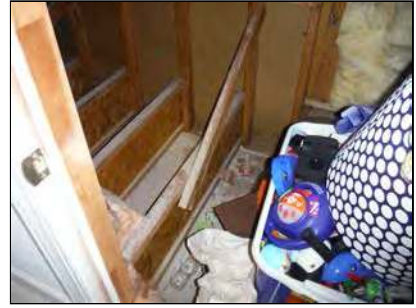
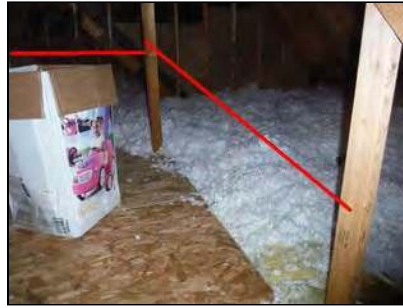
4

4. The bonus room attic and the upper attic areas do not have flooring or guard rails installed at either the entry door and/or off floored areas of the attic. This is a child safety hazard as kids open doors and go inside when playing and do not know that the sheet rock will not hold their weight. This allows the child to fall through the ceiling and into the room below causing serious and sometime fatal injury. It is recommended to install flooring or installed a locked handle to prevent children from entering.

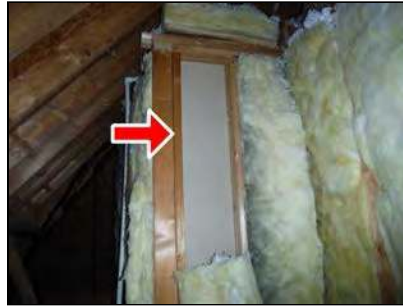
(2) Upper walk-in attic - to your left past the first corner - there was a missing section of section of insulation which needs to be installed to prevent heat loss.

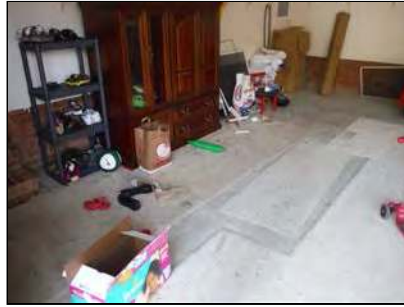
The garage walls were not fully visible due to stored items along the walls in the garage. Due to the stored items obstructing the viewing of the foundation within the garage there is no way to determine if there is termite activity. During the final walk through it is recommended that you thoroughly inspect the foundation walls for any mud tubes or you can elect to have us come back out and re-inspect the foundation walls for an additional trip fee before closing.

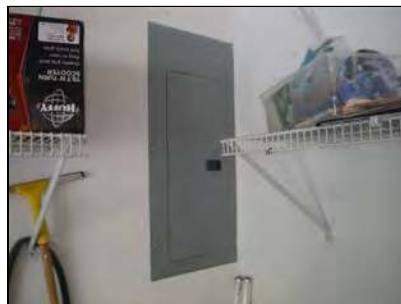
Due to the installed shelving the main electrical panel was not inspected. There should be a 36" clearance on all sides of the panel. Safe access was not available. Have the electrician review while on-site for the other noted repairs. If any items are found inside the panel they should be addressed at that time.

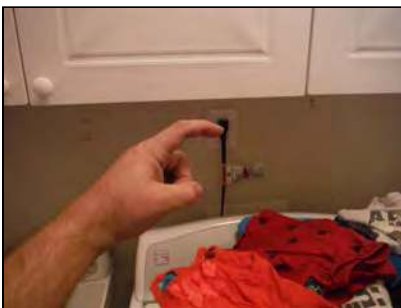
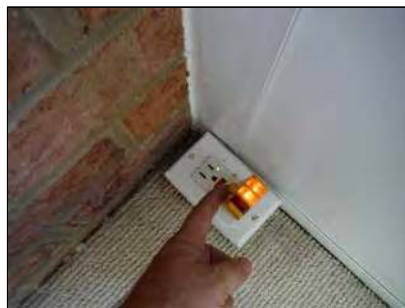
The following items were noted to be in the need of repair at GFCI locations. The conditions are safety hazards. Contact a licensed electrician for review and make any additional repairs as needed:

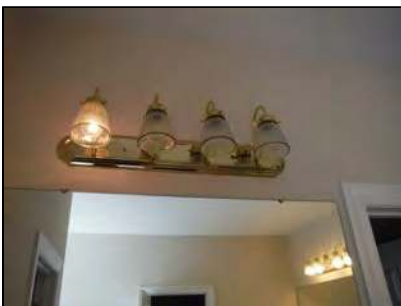
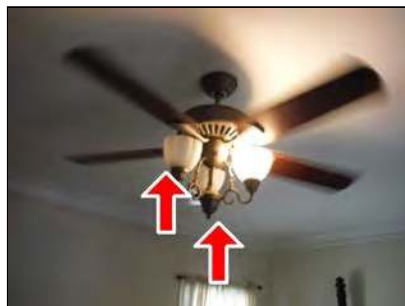
(1) Multiple lights did not function when tested. Replace the bulb and re-test to be sure it functions and is not an electrical issue. Contact a licensed electrician if replacing the bulb does not correct the issue:

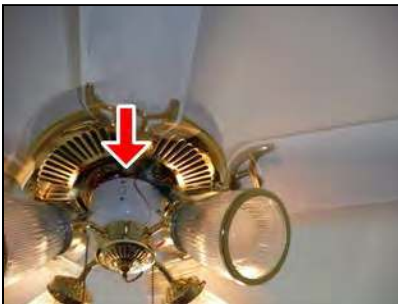
(2) Bonus room - there was a balloon string caught up in the fan which needed to be removed to prevent the motor from being damaged.

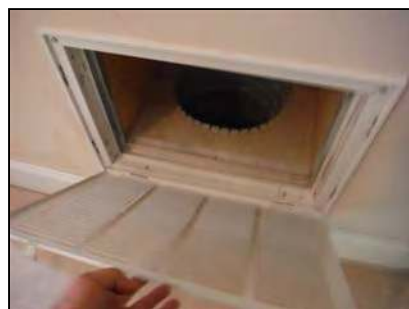
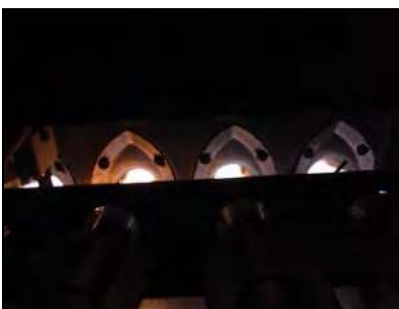
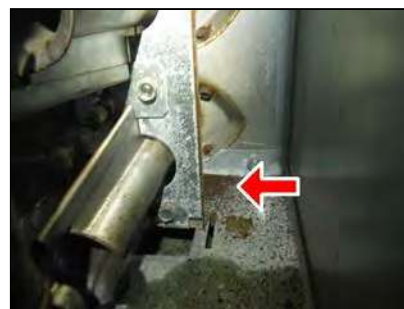
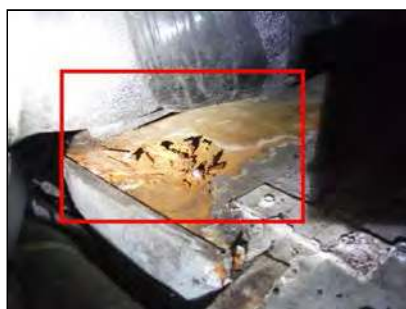
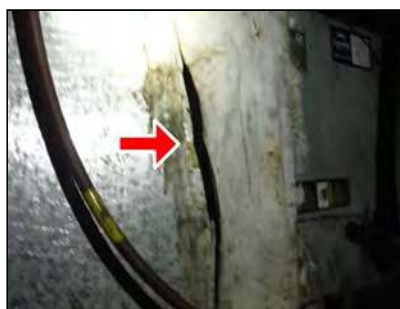
1. The air filter(s) were missing at the time of inspection, replacements needed to prevent dirt/dust particles from entering the unit. When filters are missing it is recommended that the interior components be serviced and cleaned as this can allow dirt, lint and dander to coat and cover vital parts of the a/c system. Any other items in need of repair found when the HVAC contractor cleans the unit should also be addresses.
2. The rust noted in the burner area and dancing/changing of the flame color from blue to red/orange when the house fan kicks on is an indication of a possible cracked heat exchanger. Contact a licensed HVAC contractor for a full, invasive inspection of the system. Repair/replace as needed.
3. There was rust noted at the left side of the exterior of the unit below the elbow of the vent pipe
4. Air gaps noted at the plenum need to be sealed.

Due to the following, but not limited to, it is recommended that a licensed HVAC contractor further evaluate the entire system and make any additional repairs needed:

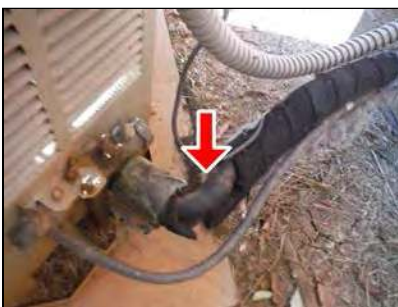
More insulation is needed on the exterior Freon line where it is worn, torn or missing

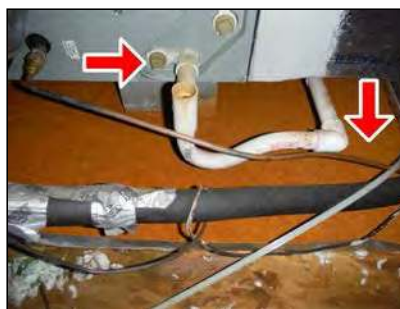
2,3

2. There was rust in the catch pan. This is an indication of the primary line being clogged at some point. The unit was off when I arrived and only ran for about an hour which is often not long enough to see if this is still an active issue. Ask the seller if a previous repair was made, if not it should be treated as an active issue in need of further evaluation.

3. Horizontal Install - There is a not a secondary drain line installed at the bottom of the evaporator coil. The secondary drain line is needed in the event that the main condensate drain line becomes clogged. This will allow water to drain into the pan below indicating that there is a problem or issues with the unit. Without the secondary drain line the water may rise to heights within the coil box causing rust/damage. A secondary drain line is recommended or sensor switch on the main drain line installed. The sensor will also shut down the unit if the primary line clogs to prevent damage

Due to the following, but not limited to, it is recommended that a licensed HVAC contractor further evaluate the entire system and make any additional repairs needed:

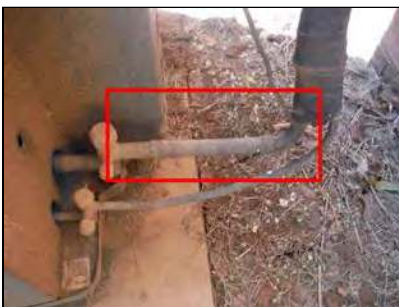
More insulation is needed on the exterior Freon line where it is worn, torn or missing

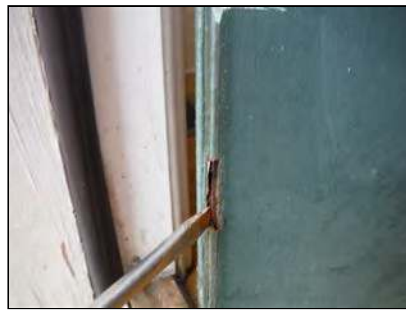
1

1. The bottom weather stripping was torn/damaged and needed to be replaced to prevent water penetration.
2. The bottom of the door is rusting. Determine cause and make repairs/replace as needed.

The following issues were noted in the need of repair and or adjustment at the front door. Contact a licensed contractor for review and make and additional repairs as needed:

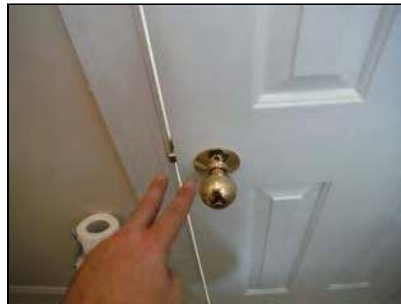
(1) The strike plates need to be adjusted at the following doors. Currently the door handle does not need to be turned for the door to be opened:

1. Master bathroom toilet closet door

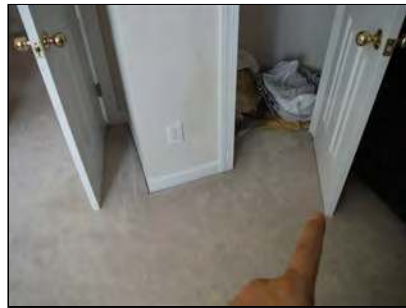
Entry door

(2) The upper, front, left bedroom entry and closet door(s) were rubbing the carpet and need to be adjusted. This causes premature wear to the carpeting, makes opening and closing the door difficult and also prevents the HVAC unit from allowing air travel between the rooms adequately. Contact a licensed contractor for review and make repairs as needed.

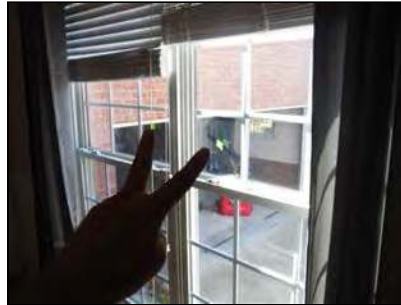
(1) The following window(s) and/or sashes (but not limited to) were found to have a bad or broken thermal window seal. The thermal window seal is the gasket that prevents moisture from entering in between the interior of the window panes and causing them to fog. The window at this point has lost its gas thus reduces the original R-Value of the window: Note: All windows are located as if looking from the inside out toward the road or yard:

1. Formal dining room - both upper sashes
2. Master bedroom - rear wall - right window - upper sash
3. Living room - both upper sashes
4. Formal living room - both upper sashes and possibly the half round
5. Sunroom - rear wall - rear wall - 2nd window to the left of the right corner and the far left window
6. Upper, left bedroom - front wall - both upper
7. Bonus room - front window - both sashes

Note: Overcast days, dirty windows, and or rain can obstruct the view of the window or make it difficult to identify a bad thermal seal. Because of this It is recommend that all windows be cleaned and further evaluated by the licensed or qualified professional. Any additional windows that are found to have bad thermal seals at that time should also be repaired or replaced by a qualified professional.

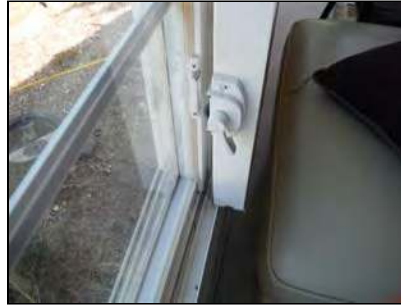
(3) Sun room - rear wall - middle window - the window is out of the track guide and needs to be repaired so that the window can be locked and prevent unwanted entry. Contact a licensed contractor for review and make any additional repairs as needed.

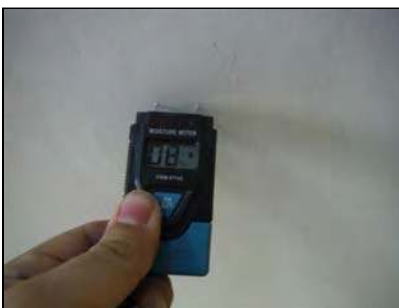
(1) There was an active moisture leak noted at the Kitchen near the sink area. This is below an upper bathroom. The reading was 8%. Contact a licensed contractor for review, determine the source/cause and make any additional repairs as needed.

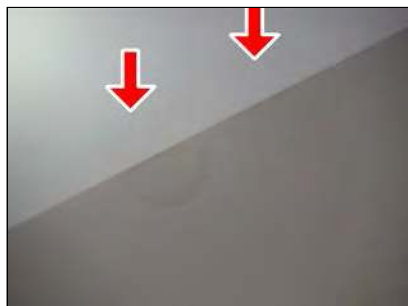
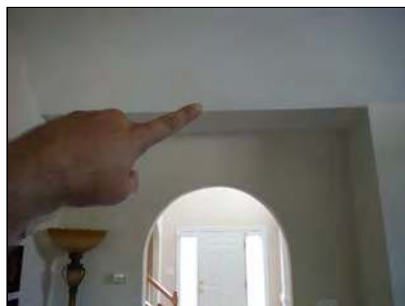
(2) Living room - above the entry way from the foyer at about the middle of the opening - there were two water stains noted in this location. Ask the seller if there was a past repair. If not, it should be treated as an active issue and further evaluated by a licensed contractor to determine the cause and make repairs as needed.

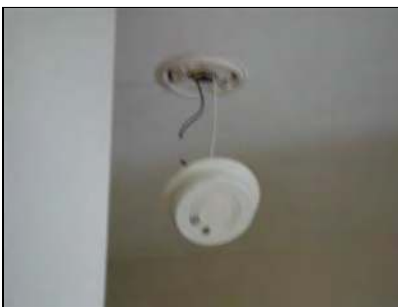
(2) The smoke detector outside the master bedroom was hanging loose from the ceiling and one of the wires has been cut. Contact a licensed electrician for review and make any additional repairs as needed.
