Inspection Report

Property Address:
1234 Money Well Spent Ln.
Charlotte NC

Americas Choice Inspections
PO Box 49271
Charlotte, NC 28277

Date: 10/5/2013	Time: 02:00 PM	Report ID:
Property: 1234 Money Well Spent Ln. Charlotte NC	Customer: Mr. Rent to Buy	Real Estate Professional:

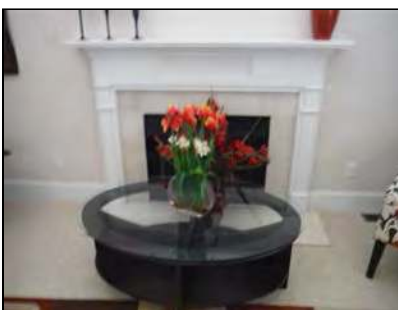
The pilot light was not lit at the time of inspection. Pilot lights must be lit at the time of inspection for the inspector to test them. If the unit has been off for some it can take a long time to get them to light and/or the air in the lines often need to be bled. The inspector does not carry lighting matches/lighters to lit units that do not have a auto igniter either. It is recommended that the pilot be lit and the unit be inspected prior to closing.

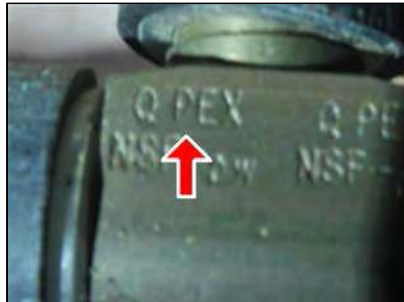
The visible plumbing lines in this home are plastic PEX with QPEX metal fittings manufactured by the Zurn Corporation. These plumbing fittings are the subject of a consumer class action lawsuit and settlement. After years of consumer complaints, the Zurn Corporation has acknowledged that it has seen an increased number of premature failures and leaks in its QPEX fittings. The client should visit the class action settlement website for more information, www.PlumbingFittingSettlement.com. A licensed plumbing contractor should be consulted for a complete inspection of the plumbing system and to make recommendations for repairs.

Multiple fittings in the crawl space show signs of failure as seen by the build up around the outside of the fitting and that can be seen through the translucent PEX on the interior.

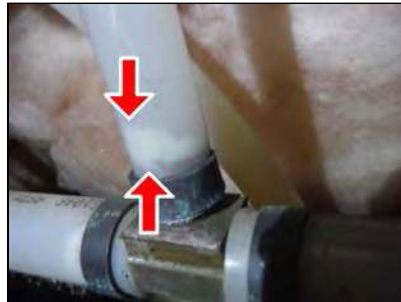
Build up inside pipe

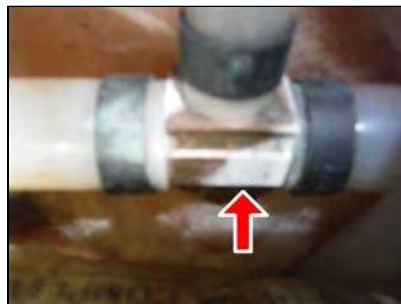
Corrosion on exterior of fitting

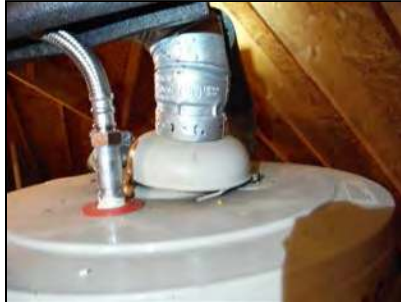
1

1. The flue is crushed down on top of the top of the water heater. It appears to be too long. Corrections are needed so there is adequate dilution air to push the flue gases up and out of the flue.
2. There are scorch marks on the front of the service door area. This is a sign of flame roll out in need of correction.

Due to the following, but not limited to, it is recommended that a licensed plumbing contractor further evaluate the water heater and make any additional repairs needed:

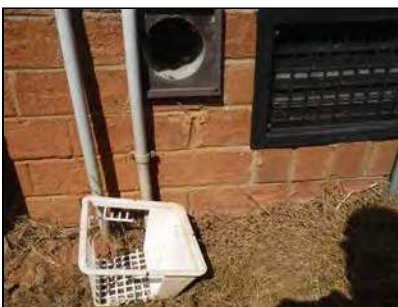
(1) Right side of home - the dryer vent cover was off at the time of inspection needed to be repaired. The flap was also missing. Contact a licensed contractor for review and make any additional repairs as needed.

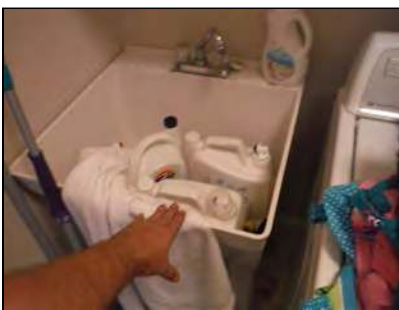
(2) The laundry room sink needs to be properly secured to the walls/floor. Currently the waste pipe and/or supply pipes are all that are holding it in place. If someone were to grab or hit the sink it could dislodge a pipe. Contact a licensed contractor for review and make any additional repairs as needed.

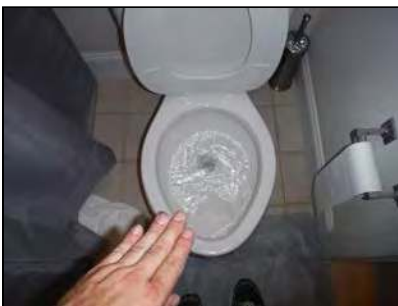
The toilet is loose at the floor and needs to be secured properly to prevent movement and or possible leakage. Note: A new wax ring should be installed under all loose toilets. As the toilet loosens the seal that is formed from the toilet loosens and the seal is not as tight as it once was. This may result is a leak allowing waste water or sewage gases into the home from a deformed wax ring. Contact a licensed plumber for review and make any additional repairs as needed.

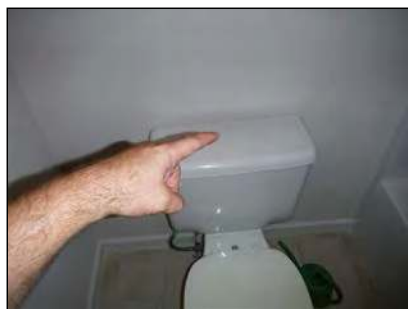
2

1. There are gaps around the tiles at the base of the toilet and the toilet itself. This can allow water to travel under the toilet as people get in and out of the shower or during mopping. The gap needs to be sealed.
2. The toilet continues to run after it has been flushed. The inlet valve float is not adjusted at a proper height and needs adjustment/replacement so that toilet will stop running when not in use.

The following items were noted to be in need of repair and or corrections at the bathroom toilet at the time of inspection. Contact a licensed contractor or plumber for review and make any additional repairs as needed:

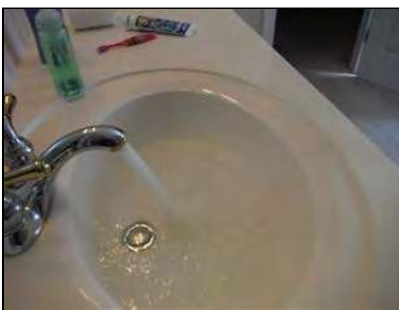
No overflow installed - The sink(s) do not have an overflow device installed. If the stopper is in use the sink will overflow into the bathroom if not turned off. Overflow devices are not required, but a great safety device. You may wish to consider replacing the sinks when you move in as an added safety feature.

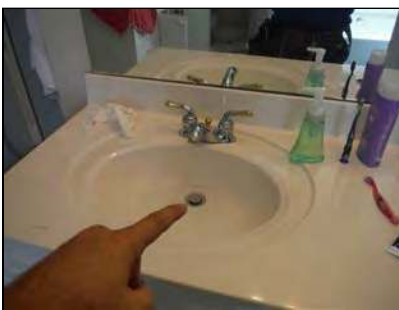
Right sink - The sink drains slow, corrections needed for the sink to drain properly. Clean the drain and re-inspect. If the sink is still slow to drain it could possibly be a venting issue. Contact a licensed contractor or plumber for further evaluation if cleaning the drain does not correct the issue.

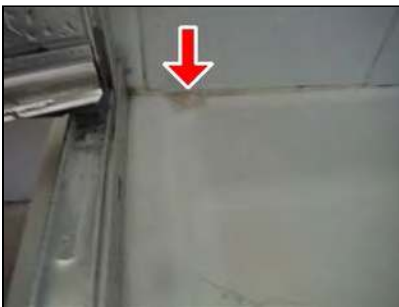
(1) The weep holes at the base of the shower wall have been sealed. These holes should be left unsealed to allow any condensation that may get behind the walls to drain back into the basin. Please Note: - There are two small holes at the front left and right corners of the shower unit or pan. They are weep holes designed to allow condensation to drain back into the shower pan/basin that may become trapped behind tiles/marble surrounds. When these holes are sealed or caulked you may possibly see water stains on a ceiling below due to the condensation becoming trapped and not being able to drain back into the shower pan/basin.

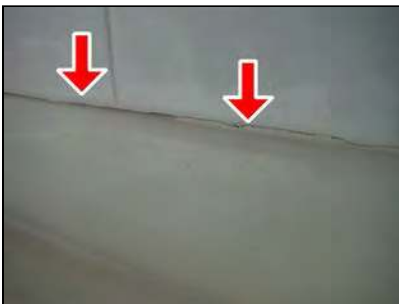
(2) Several areas in the tub/shower surround that were noted in need of additional grout or re-grouting to sealed properly and prevent water penetration.

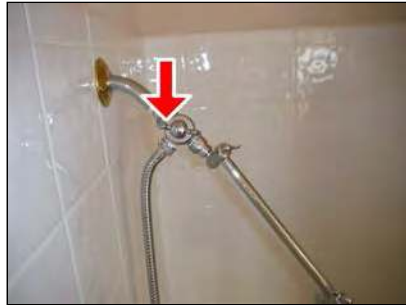
1

1. Shower - There was a leak noted at the back of the shower head where it connects to the plumbing pipe. Repairs are needed to prevent water damage. This can often be as simple as adding additional teflon tape but could possibly be from a bad gasket at the ball inside the fixture or a cracked shower head. Contact a licensed contractor for review and make any additional repairs as needed.
2. Tub - the hot/cold handles are installed reverse of each other. This makes it confusing to turn the water off once on and needs to be corrected.

The following items were noted to be in need of repair and or corrections at the bathroom shower/tub fixtures at the time of inspection. Contact a licensed contractor for review and make any additional repairs as needed:

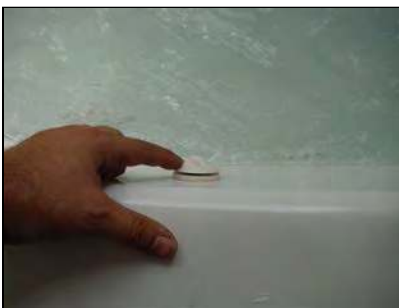
The air valve at the front, right side of the tub did not function at the time of inspection. This is needed for you to be able to adjust the "bubbles" in the tub as it allows more or less air in. Contact a licensed plumber for review and make any additional repairs as needed.

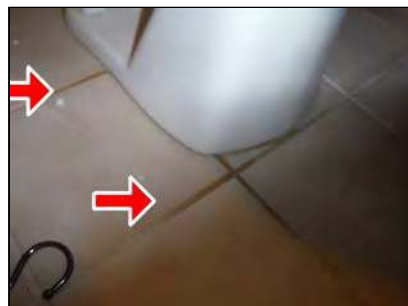
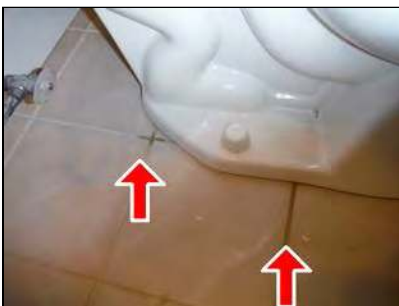
1

1. Staining or discoloration was noted on the floor around the toilet. This is indication that the toilet is leaking or has leaked in the past. Ask the sellers the history of the toilet and leaks that may have occurred. If the seller is unaware of the staining or discoloration then the toilet should be considered of having an active leak. Have a licensed plumbing contractor further evaluate the toilet and have a licensed general contractor further evaluate the flooring to ensure that there is not additional hidden or concealed damage. (See ceiling notes as possible source)
2. The toilet did not flush properly at the time of inspection. The handle must be held down to get a full flush.

The following items were noted to be in need of repair and or corrections at the bathroom toilet at the time of inspection. Contact a licensed contractor or plumber for review and make any additional repairs as needed:

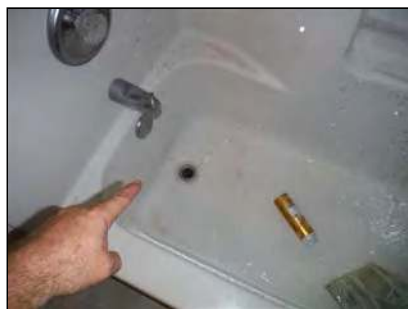
1

1. The drain stopper was missing at the time of inspection. Replacement is needed so the tub can hold water properly when bathing.
2. The tub spout is loose in the wall and there is a large gap when the diverter is used. Gaps of this type and size should not be caulked as the caulk will just pull away from the wall. The spout needs to be secured properly to prevent water penetration behind the wall.

The following items were noted to be in need of repair and or corrections at the bathroom shower/tub fixtures at the time of inspection. Contact a licensed contractor for review and make any additional repairs as needed:

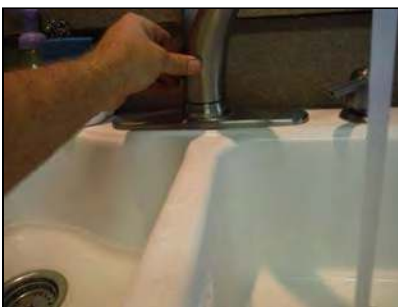
The sink faucet is loose at the base connection and needed to be re-secured. Contact a licensed contractor for review and make any additional repairs as needed.

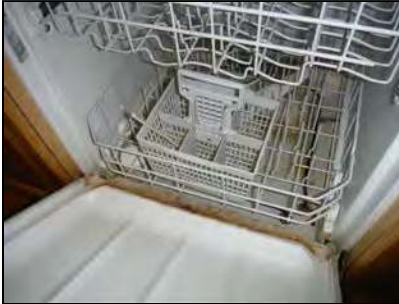
The unit filled, but would not drain or wash. Contact a qualified appliance repair person review and repair/replace as needed.
